AD No.: 2023-0136R1

AIRBUS S.A.S.

A330 and A340 aeroplanes

ATA 36 – Pneumatic – Overheat Detection System Sensing Elements – Inspection

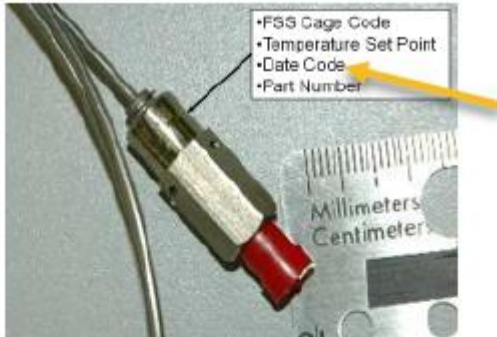
Figure 4-50. Identification Markings on Coaxial SE Male (Pin) Connector

Affected part: Overheat detection system (OHDS) sensing elements, also identified as 'Continuous Fire Detector', having a Part Number (P/N) and corresponding date code as listed in Section 1.A of

Appendix 1 of this AD provides information how to identify affected parts (P/N and date code).
