適航指令發布單

民航局AD編號 AD Number	CAA-2013-04-004C	發布日期 Date issued	2016/6/8
適用之航空產品 Applied to (models, serial numbers or part numbers, as applicable)	Kawasaki BK117 series helicopters equipped with a Goodrich rescue hoist assembly.		
主旨摘要	Equipment - Rescue Winch System - Test		
民航局 CAA <input type="checkbox"/> 本國產品 Native products <input type="checkbox"/> 其他個案 Other	設計國民航主關機構 Original Authorities <input type="checkbox"/> FAA <input type="checkbox"/> Germany LBA <input type="checkbox"/> EASA <input type="checkbox"/> CAA-NL <input type="checkbox"/> Brazil <input type="checkbox"/> UK CAA <input type="checkbox"/> Transport Canada Civil Aviation <input checked="" type="checkbox"/> Japan CAB <input type="checkbox"/> DGAC <input type="checkbox"/> CAA of Israel <input type="checkbox"/> Other _____		
	設計國AD編號 Original AD number	TCD-8201C-2016

No. TCD-8201C-2016

Airworthiness Directive

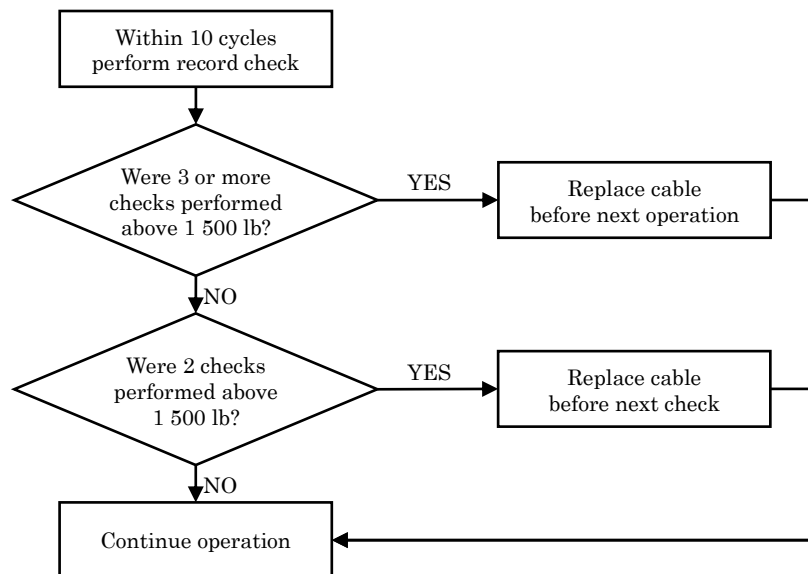
Figure 1

2.1 Within 10 hoist operating cycles after the effective date of this AD, accomplish a records check to determine whether, during any previous hoist load check/test, a cable was load-tested (average of 5 pulls) at 1 500 lb [680 kg] or more. If any cable is identified to have exceeded this limit during two or more hoist load checks/tests, replace the affected cable with a serviceable cable within the time interval shown in paragraph 2.1.1 or 2.1.2 of this AD. For replacement of a cable, see figure 1 of this AD.

2.1.1 If any cable is identified to have exceeded this limit during three or more hoist load checks/tests, before next hoist operation, replace the affected cable with a serviceable cable.

2.1.2 If any cable is identified to have exceeded this limit during two hoist load checks/tests, before the next hoist load check/test, replace the affected cable with a serviceable cable.
