適航指令發布單 Airworthiness Directive Issuance Form			
民航局 AD 編號 AD number	CAA-2015-11-005A	發布日期 Date issued	2015/12/4
適用之航空產品 Applied to (models, serial numbers or part numbers, as applicable)	This AD applies to the following helicopters, when equipped with a Goodrich hoist having a Part Number (P/N) as listed in Table 1 of this AD: AW109SP, AB139, AW139 and AB412 (all Models) helicopters, all serial numbers (s/n); BHTI 212, 214 and 412 helicopters (all Models), all s/n; BHTC 429 and 430 helicopters, all s/n; AH AS 365 N3, AS 332 L2 and EC225 LP helicopters, all s/n; AHD MBB-BK117 C-2, EC135 and EC635 (all Models) helicopters, all s/n; MDHI MD900 helicopters, all s/n; and Sikorsky S-61 (all Models), S-76A, S-76B, S-76C and S-92A helicopters, all s/n.		
主旨摘要	Equipment / Furnishings - Hoist - Test / Replacement		
民航局 CAA <input type="checkbox"/> 本國產品 Native products <input type="checkbox"/> 其他個案 Other	設計國民航主管機構 Original Authorities <div style="display: flex; flex-wrap: wrap;"> <div style="width: 50%;"> <input type="checkbox"/> FAA <input checked="" type="checkbox"/> EASA <input type="checkbox"/> Brazil <input type="checkbox"/> Transport Canada Civil Aviation <input type="checkbox"/> DGAC

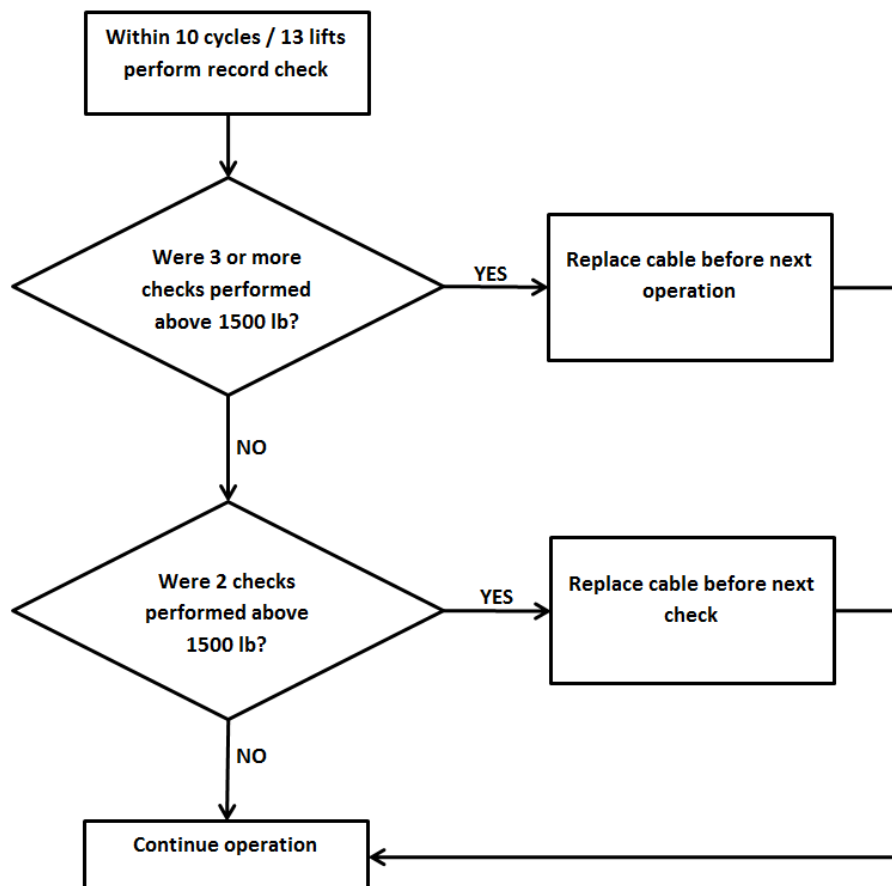
Figure 1

- (1) Within 10 hoist operating cycles or 13 hoist lifts (as applicable, see Note 1 of this AD) after the effective date of this AD, determine the P/N of the hoist installed on the helicopter and, if a Goodrich hoist is installed with a P/N listed in Table 1 of this AD, accomplish a records check to determine whether, during any previous hoist load check/test, a cable was load-tested (average of 5 pulls) at 1 500 lb [680 kg] or more. If any cable is identified to have exceeded this limit during three or more hoist load checks/tests, before next hoist operation, replace the affected cable with a serviceable cable. If any cable is identified to have exceeded this limit during two hoist load checks/tests, before the next hoist load check/test, replace the affected cable with a serviceable cable. For replacement of a cable, see figure 1 (flowchart) of this AD.
