適航指令發布單 Airworthiness Directive Issuance Form	
民航局 AD 編號 AD number	CAA-2016-07-009 發布日期 Date issued 2016/7/22
適用之航空產品 Applied to (models, serial numbers or part numbers, as applicable)	Rotax 912 A1, 912 A2, 912 A3 and 912 A4 engines, Rotax 912 F2, 912 F3 and 912 F4 engines, Rotax 912 S2, 912 S3 and 912 S4 engines, and Rotax 914 F2, 914 F3 and 914 F4 engines, all serial numbers. These engines are known to be installed on, but not limited to, the types and models aeroplanes as listed in Appendix 1 of this AD. The installation of these engines was either done by the respective aeroplane manufacturer or through modification of the aircraft by Supplemental Type Certificate.
主旨摘要	Engine Fuel and Control - Float - Inspection / Replacement
民航局 CAA <input type="checkbox"/> 本國產品 Native products <input type="checkbox"/> 其他個案 Other	設計國民航主管機構 Original Authorities <input type="checkbox"/> FAA <input checked="" type="checkbox"/> EASA <input type="checkbox"/> Brazil <input type="checkbox"/> Transport Canada Civil Aviation <input type="checkbox"/> DGAC <input type="checkbox"/> Germany LBA <input type="checkbox"/> CAA-NL <input type="checkbox"/> UK CAA <input type="checkbox"/> Japan CAB <input type=

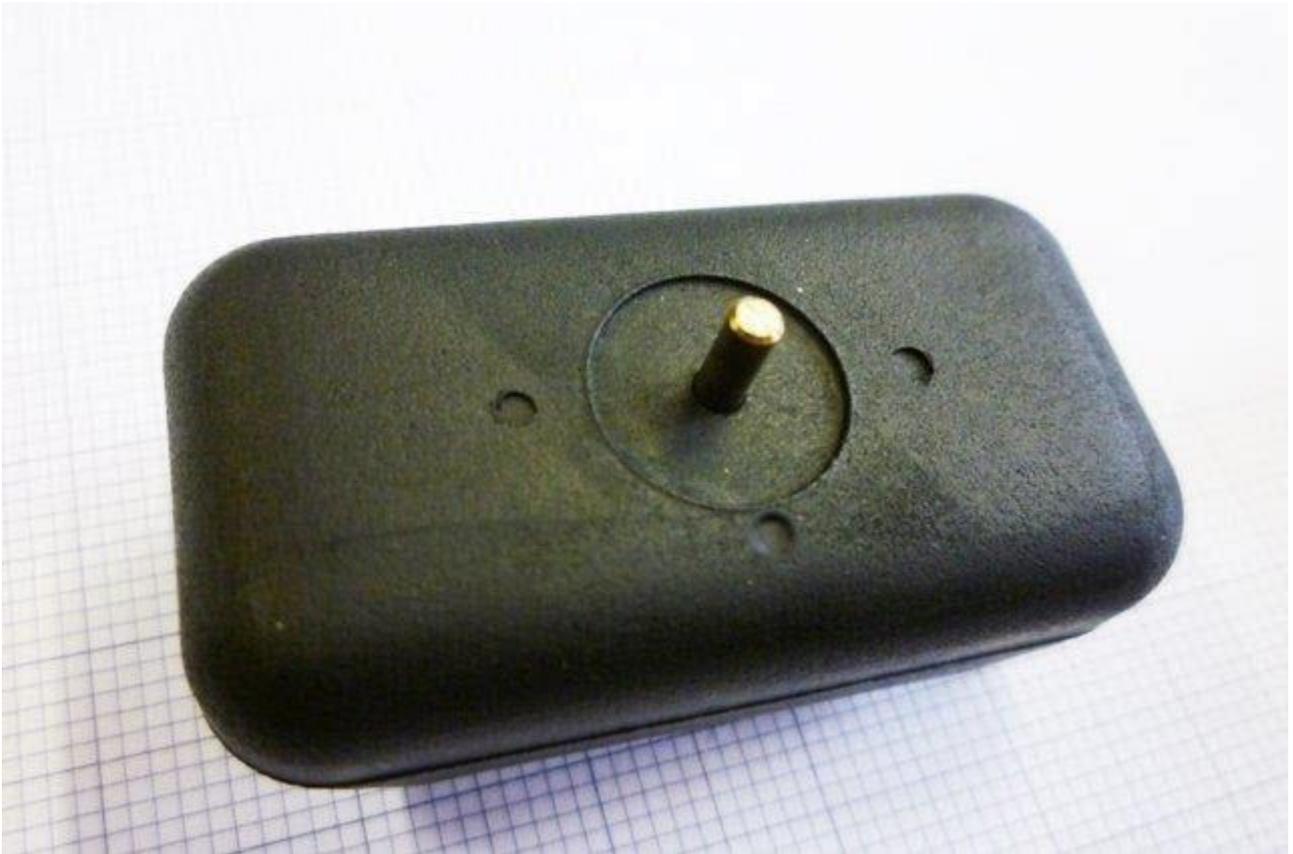
Appendix 3 – Float with 3 dots

Note 2: For the purpose of this AD, an affected float is float having P/N 861185, that has been initially delivered on a date between 09 May 2016 and 17 July 2016 (inclusive), and that does not have 3 dots. Certification documents (e.g., Form 1), delivery document or record of previous installation of the float are acceptable to determine an initial delivery on or before 08 May 2016. An example of a serviceable float having 3 dots is shown in Appendix 3 of this AD.

- (2) For any affected engine, before next flight after the inspection as required by paragraph (1) of this AD, replace any affected float with a serviceable float (see Note 2 and Appendix 3 of this AD) in accordance with the instructions of the ASB.
