適航指令發布單

民航局AD編號 AD Number	CAA-2016-11-008	發布日期 Date issued	2016/11/17
適用之航空產品 Applied to (models, serial numbers or part numbers, as applicable)	The Boeing Company Model 777-200, -200LR, -300, and -300ER series airplanes, certificated in any category.		
主旨摘要	FUEL - Left and Right Engine Fuel Spar Valve Control Relay and Wiring - Modification		
民航局 CAA <input type="checkbox"/> 本國產品 Native products <input type="checkbox"/> 其他個案 Other	設計國民航主關機構 Original Authorities <input checked="" type="checkbox"/> FAA <input type="checkbox"/> EASA <input type="checkbox"/> Brazil <input type="checkbox"/> Transport Canada Civil Aviation <input type="checkbox"/> DGAC <input type="checkbox"/> Germany LBA <input type="checkbox"/> CAA-NL <input type="checkbox"/> UK CAA <input type="checkbox"/> Japan CAB <input type="checkbox"/> CAA of Israel <input type="checkbox"/> Other _____		
	設計國AD編號 Original AD number	2016-21-05

[Docket No. FAA-2015-7527; Directorate Identifier 2015-NM-094-AD; Amendment 39-18686; AD 2016-21-05]

Airworthiness Directives; The Boeing Company Airplanes

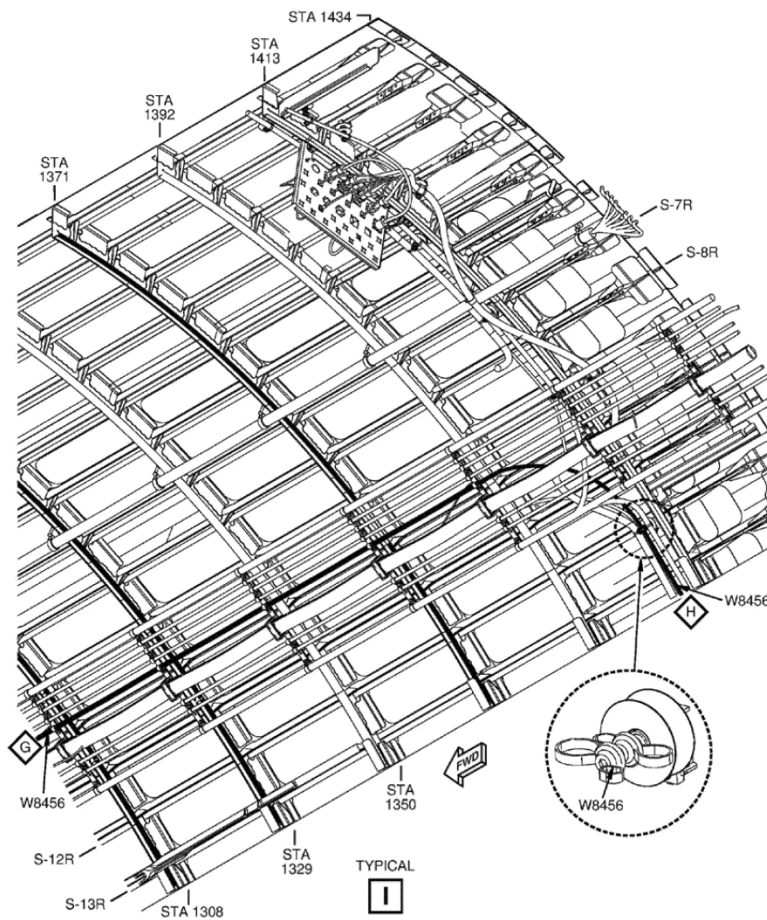
Figure 1 to paragraph (h) of this AD: *Wiring Installation - Right Engine Fuel Spar Valve*

We partially agree with the commenter's request. We cannot include Boeing Service Bulletin Information Notice 777-28-0061, IN 03, dated November 16, 2015, as an appropriate source of service information in this AD because it is not an FAA-approved document. However, we acknowledge that for certain airplanes, Figure 22, Sheet 9, of Boeing Special Attention Service Bulletin 777-28-0061, Revision 2, dated May 4, 2015, includes an editorial error, which shows incorrect wire routing. Boeing Service Bulletin Information Notice 777-28-0061, IN 03, dated November 16, 2015, allows for a modification of Group 2 airplanes that meets the requirements of the AD without an additional burden to operators. We have included a corrected figure in paragraph (h) of this AD to address this issue.

This AD was prompted by a report indicating that the manufacturer discovered locations where the control components and wiring of the left and right engine fuel spar valves do not have adequate physical separation to meet the redundant system separation requirements. We are issuing this AD to prevent loss of control of both the left and right engine fuel spar valves during a single event, such as local wire bundle damage or a wire bundle fire, which could cause both engines to shut down or result in the inability to control an engine fire.

(1) Where Boeing Special Attention Service Bulletin 777-28-0061, Revision 2, dated May 4, 2015, specifies to use Figure 22, Sheet 9, for the wiring installation of the right engine fuel spar valve, this AD requires using figure 1 to paragraph (h) of this AD.
