## 適航指令發布單

民航局AD編號 AD Number	CAA-2018-01-006	發布日期 Date issued	2018/1/29
適用之航空產品 Applied to (models, serial numbers or part numbers, as applicable)	Honeywell International Inc. (Honeywell) TPE331-1, -2, -2UA, -3U, -3UW, -5, -5A, -5AB, -5B, -6, -6A, -8, -10, -10AV, -10GP, -10GT, -10N, -10P, -10R, -10T, -10U, -10UA, -10UF, -10UG, -10UGR, -10UR, and -11U, -12JR, -12UA, -12UAR, -12UHR, -25AA, -25AB, -25DA, -25DB, -25FA, -43A, -43BL, -47A, -55B, and -61A model turboprop engines, and TSE331-3U model turboshaft engines.		
主旨摘要	Turbine Engine Combustion Section - To prevent failure of the combustion chamber case assembly		
民航局 CAA  <input type="checkbox"/> 本國產品 Native products  <input type="checkbox"/> 其他個案 Other	設計國民航主關機構 Original Authorities <input checked="" type="checkbox"/> FAA <input type="checkbox"/> EASA <input type="checkbox"/> Brazil <input type="checkbox"/> Transport Canada Civil Aviation <input type="checkbox"/> DGAC <input type="checkbox"/> Germany LBA <input type="checkbox"/> CAA-NL <input type="checkbox"/> UK CAA <input type="checkbox"/> Japan CAB <input type="checkbox"/> CAA of Israel <input type="checkbox"/> Other _____

**[Docket No. FAA-2016-9418; Product Identifier 2016

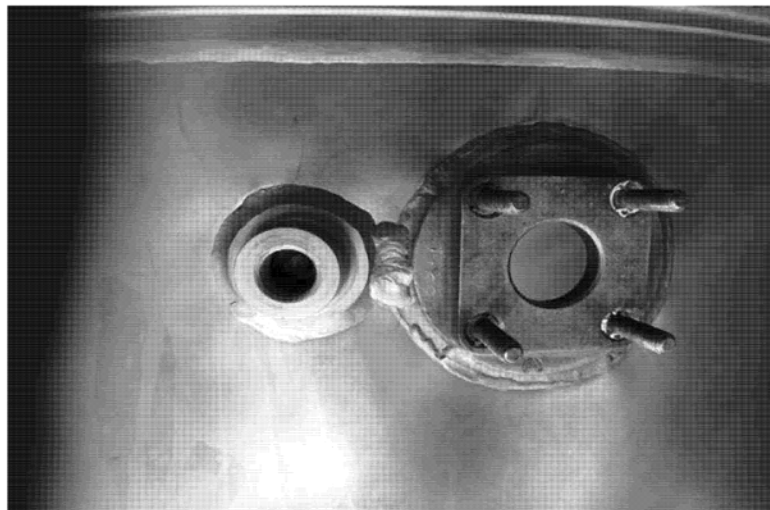
**Figure 1 to Paragraph (h) of this AD. Combustion Chamber Case Assembly**

TPE331 model engines modified by STC SE383CH may be defined as the “Super 1” and “Super 2” for the compressor modification of the TPE331-1 and the TPE331-2, -2U, and -2UA engines, respectively. Figures 1 and 2 to paragraph (h) of this AD illustrate the appearance of combustion chamber case assembly, P/N 893973-5, without and with, respectively, the one-piece bleed pad with the P3 boss.

**Without the One-Piece Bleed Pad with P3 Boss**

(2) For TPE331-3U, -3UW, -5, -5A, -5AB, -5B, -6, and -6A engines with combustion chamber case assemblies, P/Ns 869728-1, 869728-3, or 893973-5, installed, and without the one-piece bleed pad with P3 boss; and for TPE331-1, -2, and -2UA engines modified by National Flight Services, Inc., supplemental type certificate (STC) SE383CH, remove the combustion chamber case assembly from service at the next removal of the combustion chamber case from the engine, not to exceed 3,700 hours time-in-service since last hot section inspection.

After the effective date of this AD, do not install a combustion chamber case assembly, P/N 869728-1, 869728-3, or 893973-5, in TPE331-3U, -3UW, -5, -5A, -5AB, -5B, -6, and -6A engines or in TPE331-1, -2, and -2UA engines modified by National Flight Services, Inc., STC SE383CH, unless the combustion chamber case assembly has a one-piece bleed pad with P3 boss.

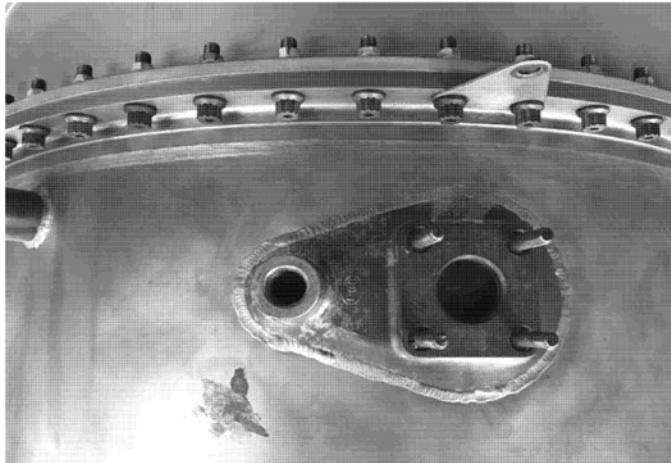
**Figure 2 to Paragraph (h) of this AD. Combustion Chamber Case Assembly with  
One-Piece Bleed Pad with P3 Boss**

We agree. We note that five of the six combustion chamber case assemblies that ruptured were assemblies without the one-piece bleed pad. P/N 3101668-x has the one-piece bleed pad with P3 boss, which demonstrated significantly reduced cracking between the P3 and bleed boss; therefore, this combustion chamber case assembly is not affected by this AD. No further changes are needed. We did not change this AD.
