適航指令發布單

AD No.: 2018-0226

A330 and A340 aeroplanes

ATA 55 – Stabilizers - Horizontal Stabilizer Centre Box Top Skin – Inspection / Repair

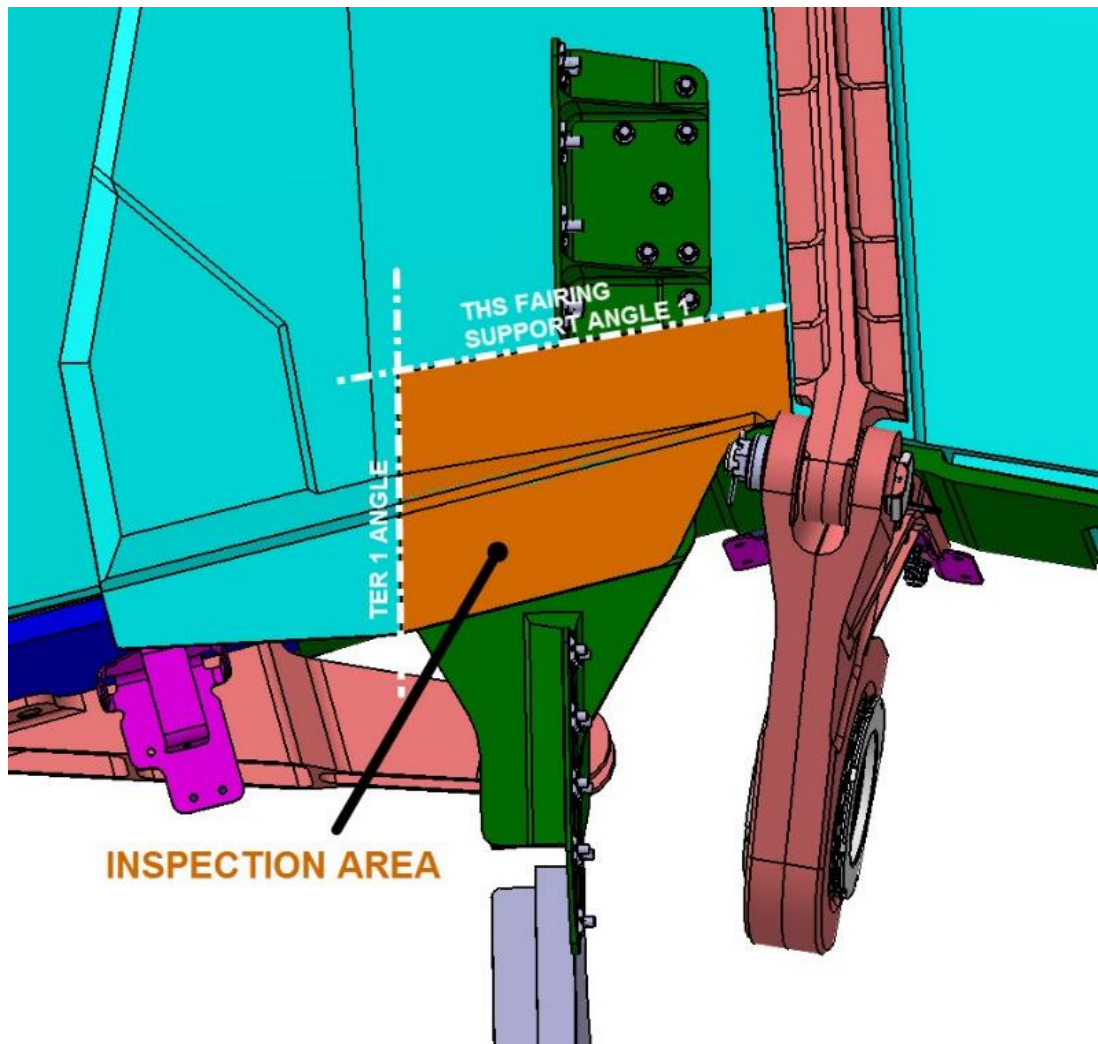
Appendix 1– Affected area to be inspected

Cracks were found in the horizontal stabilizer (HS) centre box (CB) top skin of an A330 aeroplane in pre-mod 41330 configuration. The cracks were initiated at the upper flange corner at Rib 3 rear spar area on left hand side of the CB.

This condition, if not detected and corrected, could lead to reduced structural integrity of the HS CB of the aeroplane.

- (4) If, during any inspection as required by paragraphs (1), (2) or (3) of this AD, as applicable, any crack is found, before next flight, contact Airbus for approved repair instructions and, within the compliance time specified in those instructions, accomplish those instructions accordingly.
