適航指令發布單

民航局 AD 編號 AD number	CAA-2019-10-006	發布日期 Date issued	2019/10/16
適用之航空產品 Applied to (models, serial numbers or part numbers, as applicable)	This AD applies to all The Boeing Company Model 787-8, 787-9, and 787-10 airplanes, certificated in any category.		
主旨摘要	This AD requires repetitive operational checks of the leading edge outboard slats and applicable on-condition actions, and also requires revising (AFM) to prohibit flap retraction under icing conditions and revising the existing maintenance or inspection program, as applicable, to incorporate a new operation check.		
民航局 CAA <input type="checkbox"/> 本國產品 Native products <input type="checkbox"/> 其他個案 Other	設計國民航主管機構 Original Authorities <input checked="" type="checkbox"/> FAA <input type="checkbox"/> EASA <input type="checkbox"/> Brazil <input type="checkbox"/> Transport Canada Civil Aviation <input type="checkbox"/> DGAC <input type="checkbox"/> Germany LBA <input type="checkbox"/> CAA-NL <input type="checkbox"/> UK CAA <input type="checkbox"/> Japan CAB <input type="checkbox"/> CAA of Israel <input type="checkbox"/> Other _____

[Docket No. FAA-2019-0715; Product Identifier 2019-NM-151-AD; Amendment 39-19760; AD 2019

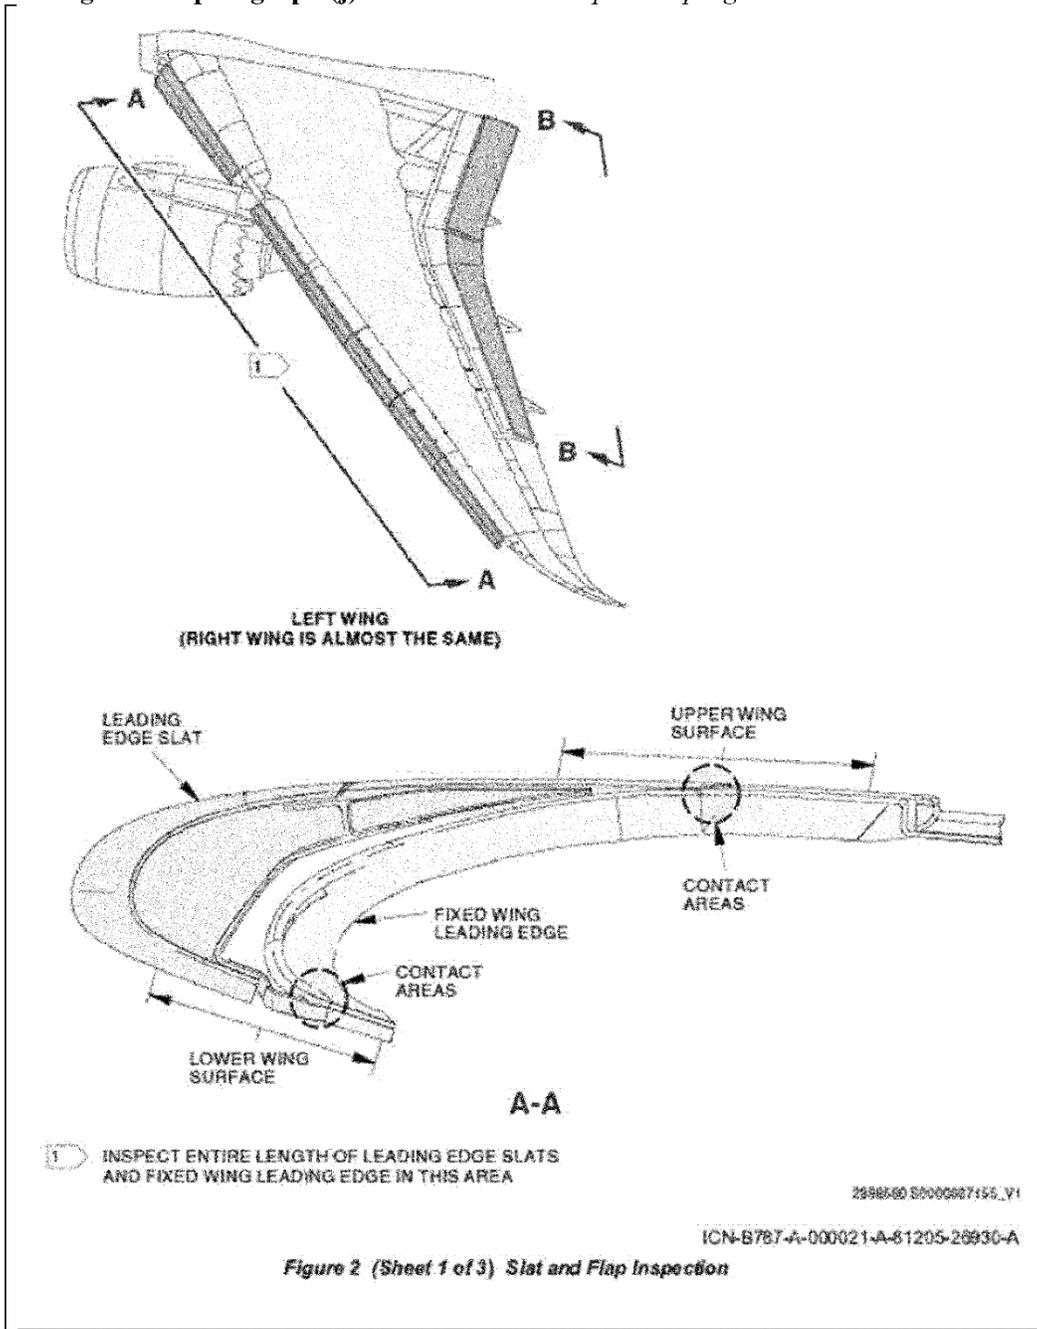
Figure 2 (Sheet 1 of 3) Slat and Flap Inspection

After any landing in icing conditions, do this inspection with the slats/flaps (flaps 25 detent) fully extended (Figure 2):

- (a) Examine these areas for contaminants (ice, snow, slush):

- 1) Slats/flaps surfaces
- 2) Leading edge contact surfaces

- 3) Slat actuation areas, including exposed areas of the slat track cavity, and slat cove
- 4) Flap tracks, hinges, seals

- (b) Remove the contamination that you find.

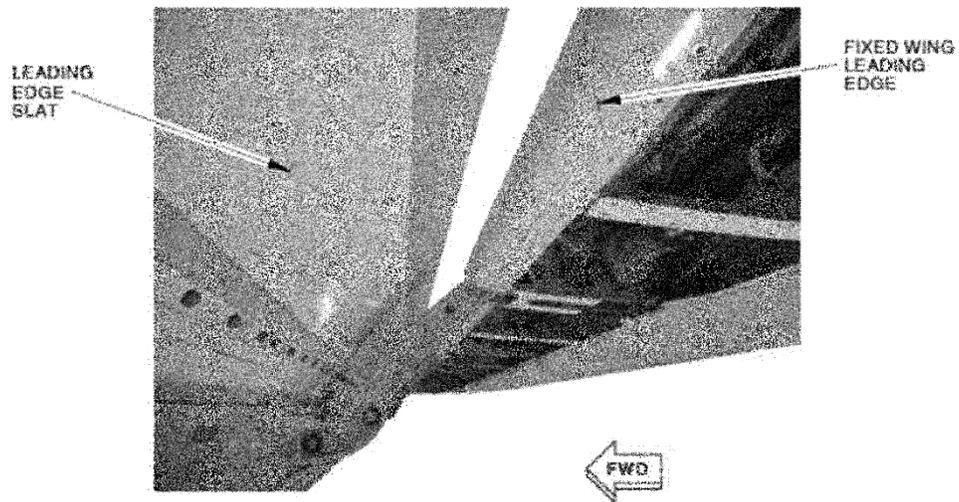
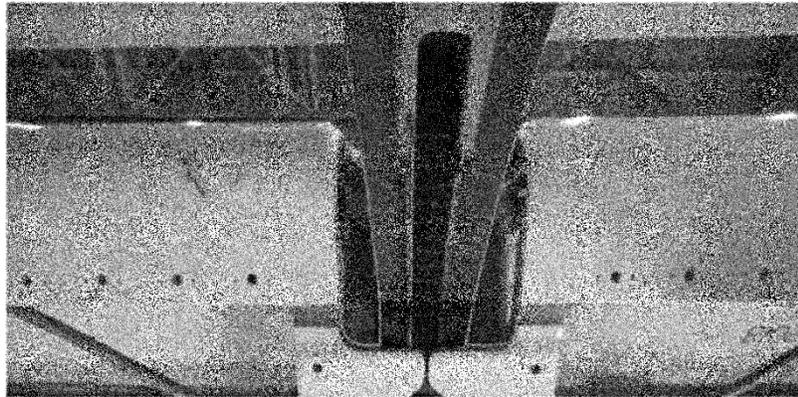
Figure 2 (Sheet 2 of 3) Slat and Flap Inspection

**ACTUATION AREAS
(TYPICAL)
A-A**

**SLAT TRACK CAVITY
(TYPICAL)
(VIEW IN THE AFT DIRECTION)
A-A**
