適航指令發布單

民航局 AD 編號 AD number	CAA-2020-02-010	發布日期 Date issued	2020/2/21
適用之航空產品 Applied to (models, serial numbers or part numbers, as applicable)	Model MD-11 and MD-11F airplanes modified by supplemental type certificate (STC) ST01895WI. and Model 717-200 airplanes modified by STC ST04416AT. and All Model 737-8 and 737-9 airplanes. and All Model 737-600, -700, -700C, -800, -900, and -900ER series airplanes. and Model 747-400 and 747-400F series airplanes modified by STC ST01892WI. and Model 757-200, -200PF, -200CB, and -300 series airplanes modified by STC ST04436AT. and Model 767-200, -300, -300F, -400ER, and -2C series airplanes modified by STC ST04436AT or ST01883WI. and All Model 777-200, -200LR, -300, and -300ER series airplanes. and All Model 777F series airplanes.		
主旨摘要	This AD requires revising the existing airplane flight manual to include a limitation to prohibit operations that require less than 0.3 required navigational performance within a specified area for airplanes having a certain multi-mode receiver with certain software installed.

[Docket No. FAA-2020-0098; Product Identifier 2020-NM-011-AD; Amendment 39-19844; AD 2020-03-20]

Airworthiness Directives; The Boe

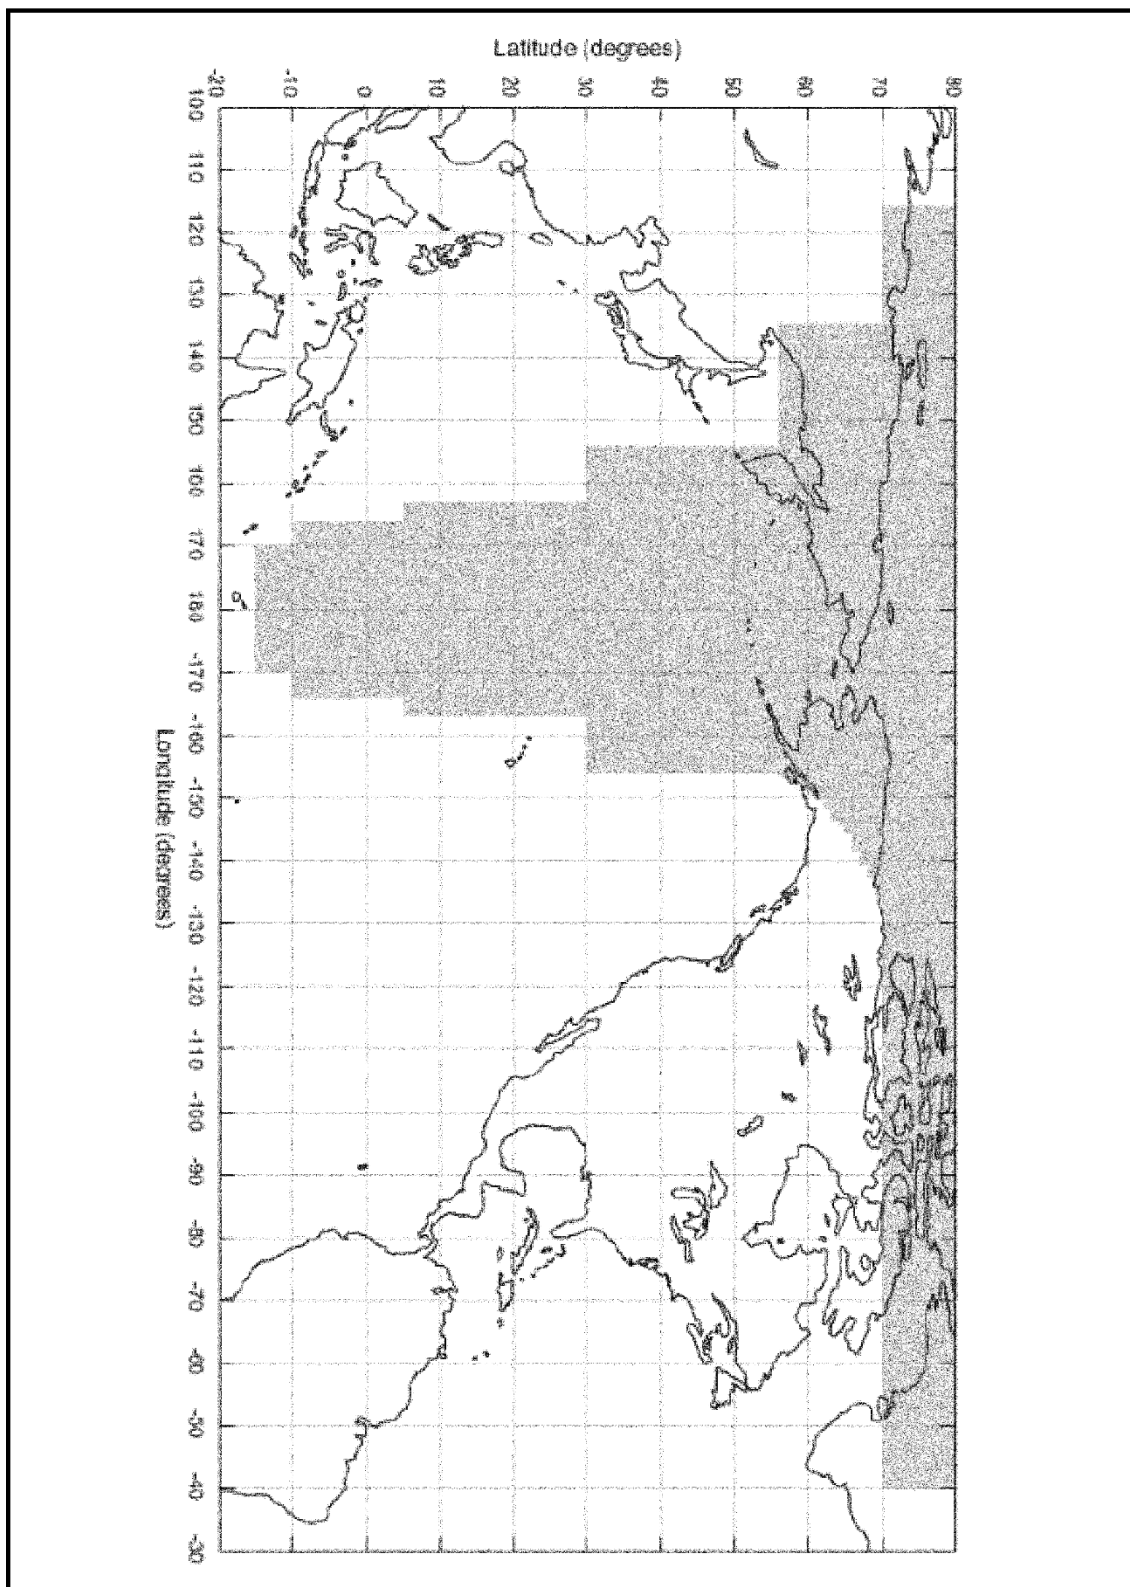
Figure 2 to paragraph (g) – AFM – Limitations or Certificate Limitations continued

Operations that require less than 0.3 RNP (For example, 0.1, 0.11, 0.15, etc.) in the region identified below are prohibited with GLU-2100 OPS software number COL4D-0087-0002, COL4E-0087-0001, COL48-0087-0700, or COL49-0087-0701 installed.

Region bounded by the following coordinates:

Latitude Range (degrees)	Longitude Range (degrees)
80 N to 70 N	40 E to 40 W
70 N to 69 N	134.5 E to 134.38 W
69 N to 68 N	134.5 E to 137.28 W
68 N to 67 N	134.5 E to 139.50 W
67 N to 66 N	134.5 E to 141.58 W
66 N to 65 N	134.5 E to 144.23 W
65 N to 64 N	134.5 E to 145.48 W
64 N to 63 N	134.5 E to 146.44 W
63 N to 62 N	134.5 E to 148.33 W
62 N to 61 N	134.5 E to 149.50 W
61 N to 60 N	134.5 E to 150.35 W
60 N to 59 N	134.5 E to 151.00 W
59 N to 58 N	134.5 E to 151.40 W
58 N to 57 N	134.5 E to 152.62 W
57 N to 56 N	134.5 E to 153.42 W
56 N to 30 N	154 E to 154 W
30 N to 5 N	163 E to 163 W
5 N to 10 S	166 E to 166 W
10 S to 15 S	170 E to 170 W
