適航指令發布單

AD No.: 2020-0097R1

ATR 42 and ATR 72 aeroplanes

ATA 53 – Fuselage – Passenger Seat Tracks – Inspection / Repair / Replacement

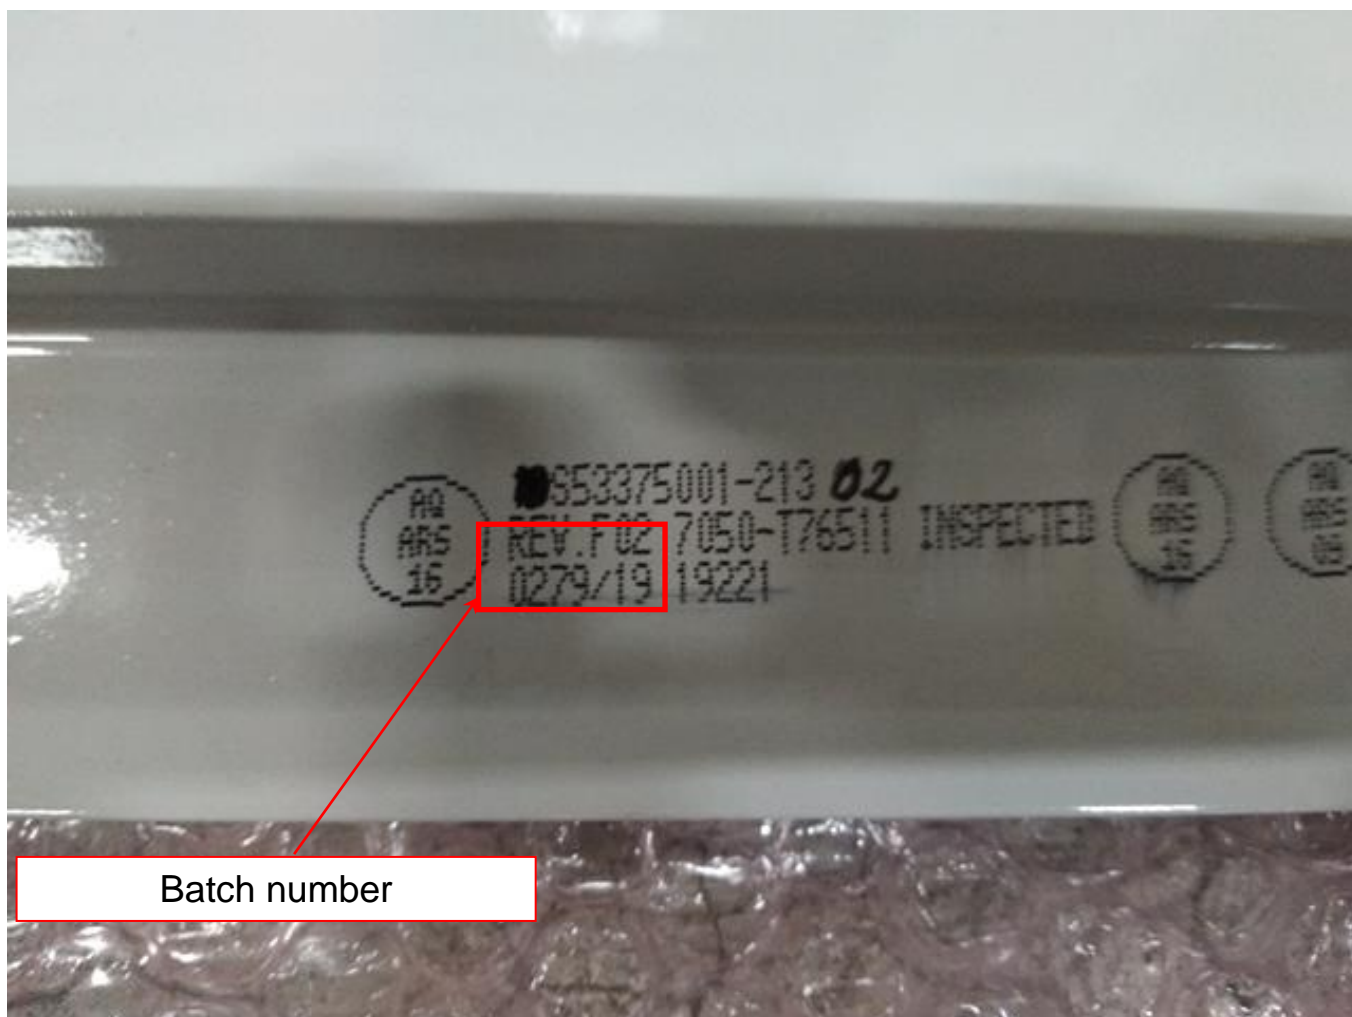
APPENDIX 1 – Seat Track Manufacturing Batch Number

The batch number is located on the lower face of the seat track.

The batch number of the represented seat track above is 0279/19.

/19 represents the production year of the seat track.

All the seat tracks with a batch number having /12 up to /17, or with a batch number not visible/legible, have to be considered as potential affected parts.
