## 適航指令發布單

## **BRAZILIAN AIRWORTHINESS DIRECTIVE**

**AD No.: 2021-02-02**

### **AD No. 2021-02-02 - YABORÃ/EMBRAER / 39-1478.**

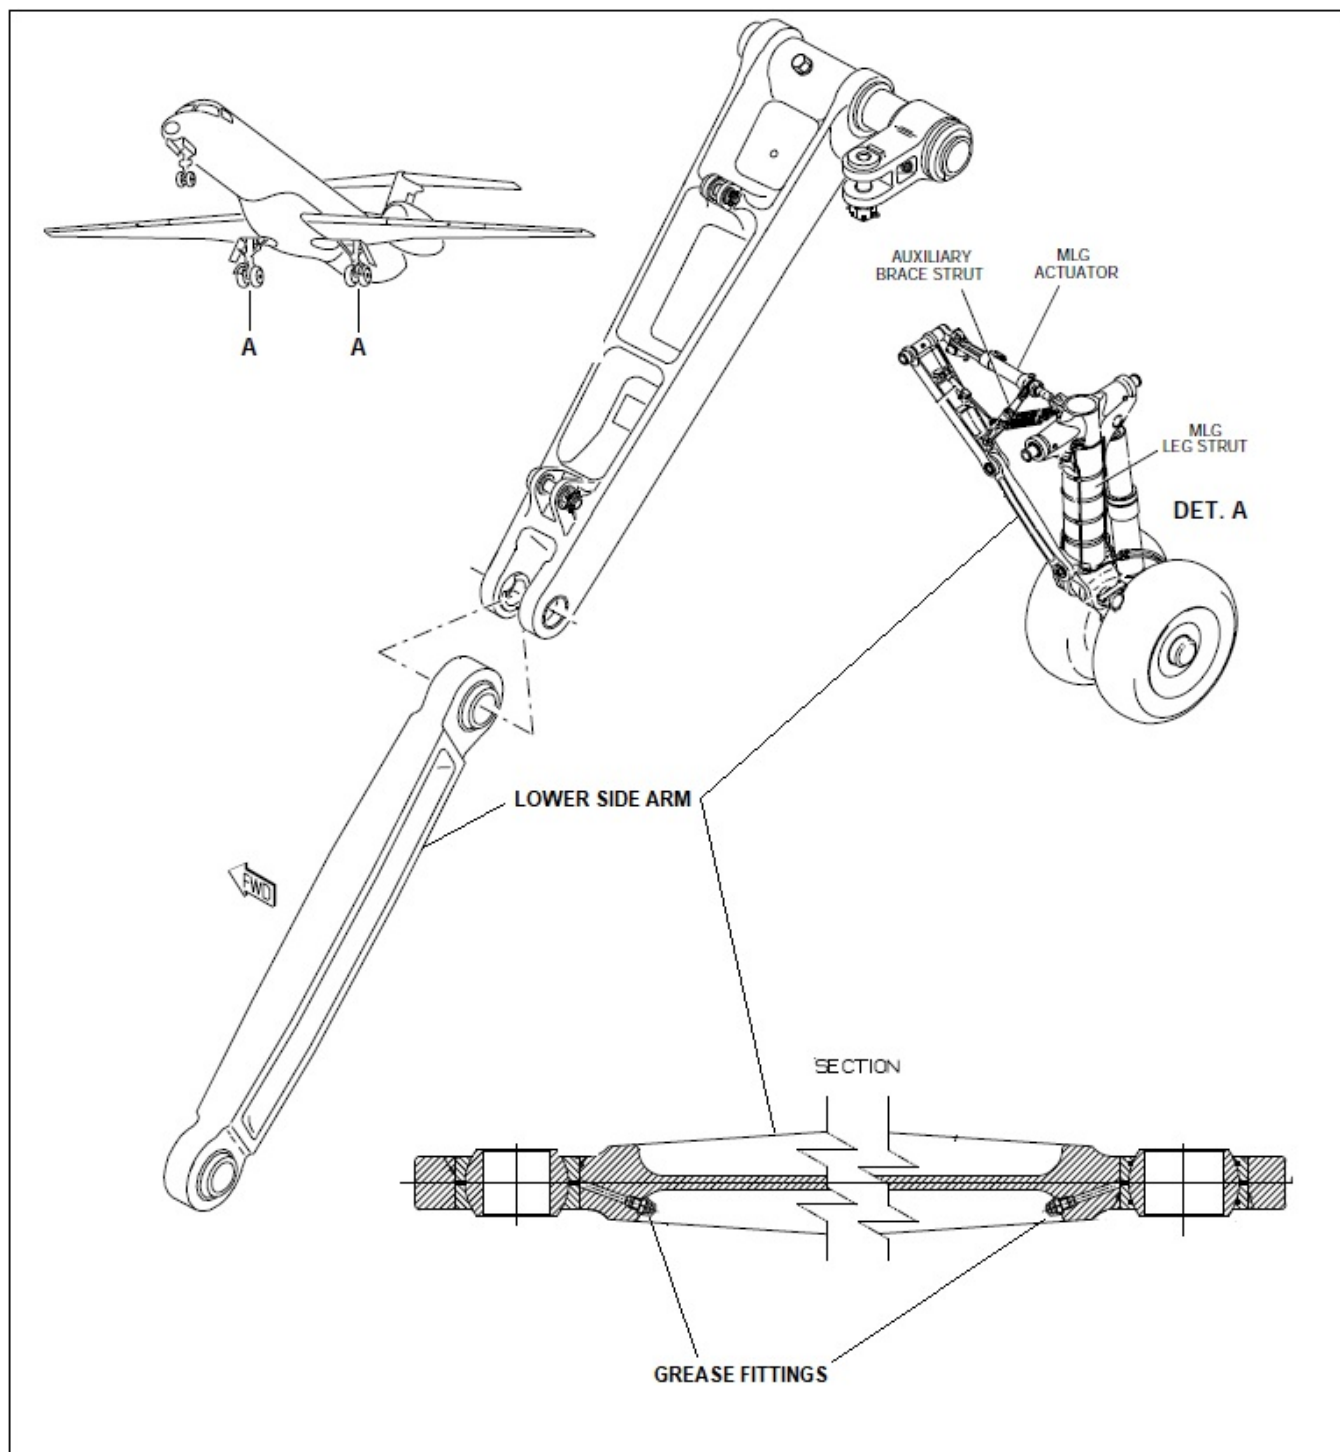
Figure 1: MLG Lower Side Arm correct grease fittings installation

The inspection revealed one occurrence of an MLG Lower Side Arm installed on an aircraft possessing grease fittings on both of its sides. This is not an approved configuration as the MLG Lower Side Arm must have both of its grease fittings installed on the same side (see Figure 1 below).

An MLG Lower Side Arm with grease fittings on both of its sides could lead to a misinterpretation of the MLG assembly instructions which could culminate in an inverted installation of the MLG Side Arm Strut Bearings since the grease fittings installation side on the Lower Side Arm are used as a reference to the correct installation of the Bearings.

A one-time inspection, and replacement of the MLG Lower Side Arm by a serviceable part (see NOTE 1), if necessary, as to the correct positioning of the grease fittings (see Figure 1).

NOTE 1: A serviceable MLG Lower Side Arm (P/Ns 2309-2532-001 or 2309-2532-003) is one that has both grease fittings installed on the same side of the part (see Figure 1).

1. Verify that both grease fittings are installed on the same side of the MLG Lower Side Arm and that both are facing the flight direction;
  - i. If, during the inspection required by item (a)(1) above, it is found that the grease fittings are installed on opposite sides of the MLG Lower Side Arm (one grease fitting on one side and the other on the opposite side), before the next flight (see NOTE 2), replace the MLG Lower Side Arm by a serviceable part (see NOTE 1), according to the instructions of the AMM (Aircraft Maintenance Manual), procedure MPP1124\_32-10-03-04-1;

- ii. If, during the inspection required by item (a)(1) above, it is found that both grease fittings are facing opposite to the flight direction, before the next flight (see NOTE 2), remove the Lower Side Arm and re-install it on the correct position (both grease fittings facing the flight direction – see Figure 1), according to the instructions of the AMM, procedure MPP1124\_32-10-03-04-1.
