Airworthiness Directive Issuance Form

BRAZILIAN AIRWORTHINESS DIRECTIVE

AD No.: 2021-02-02

AD No. 2021-02-02 - YABORÃ / 39-1478.

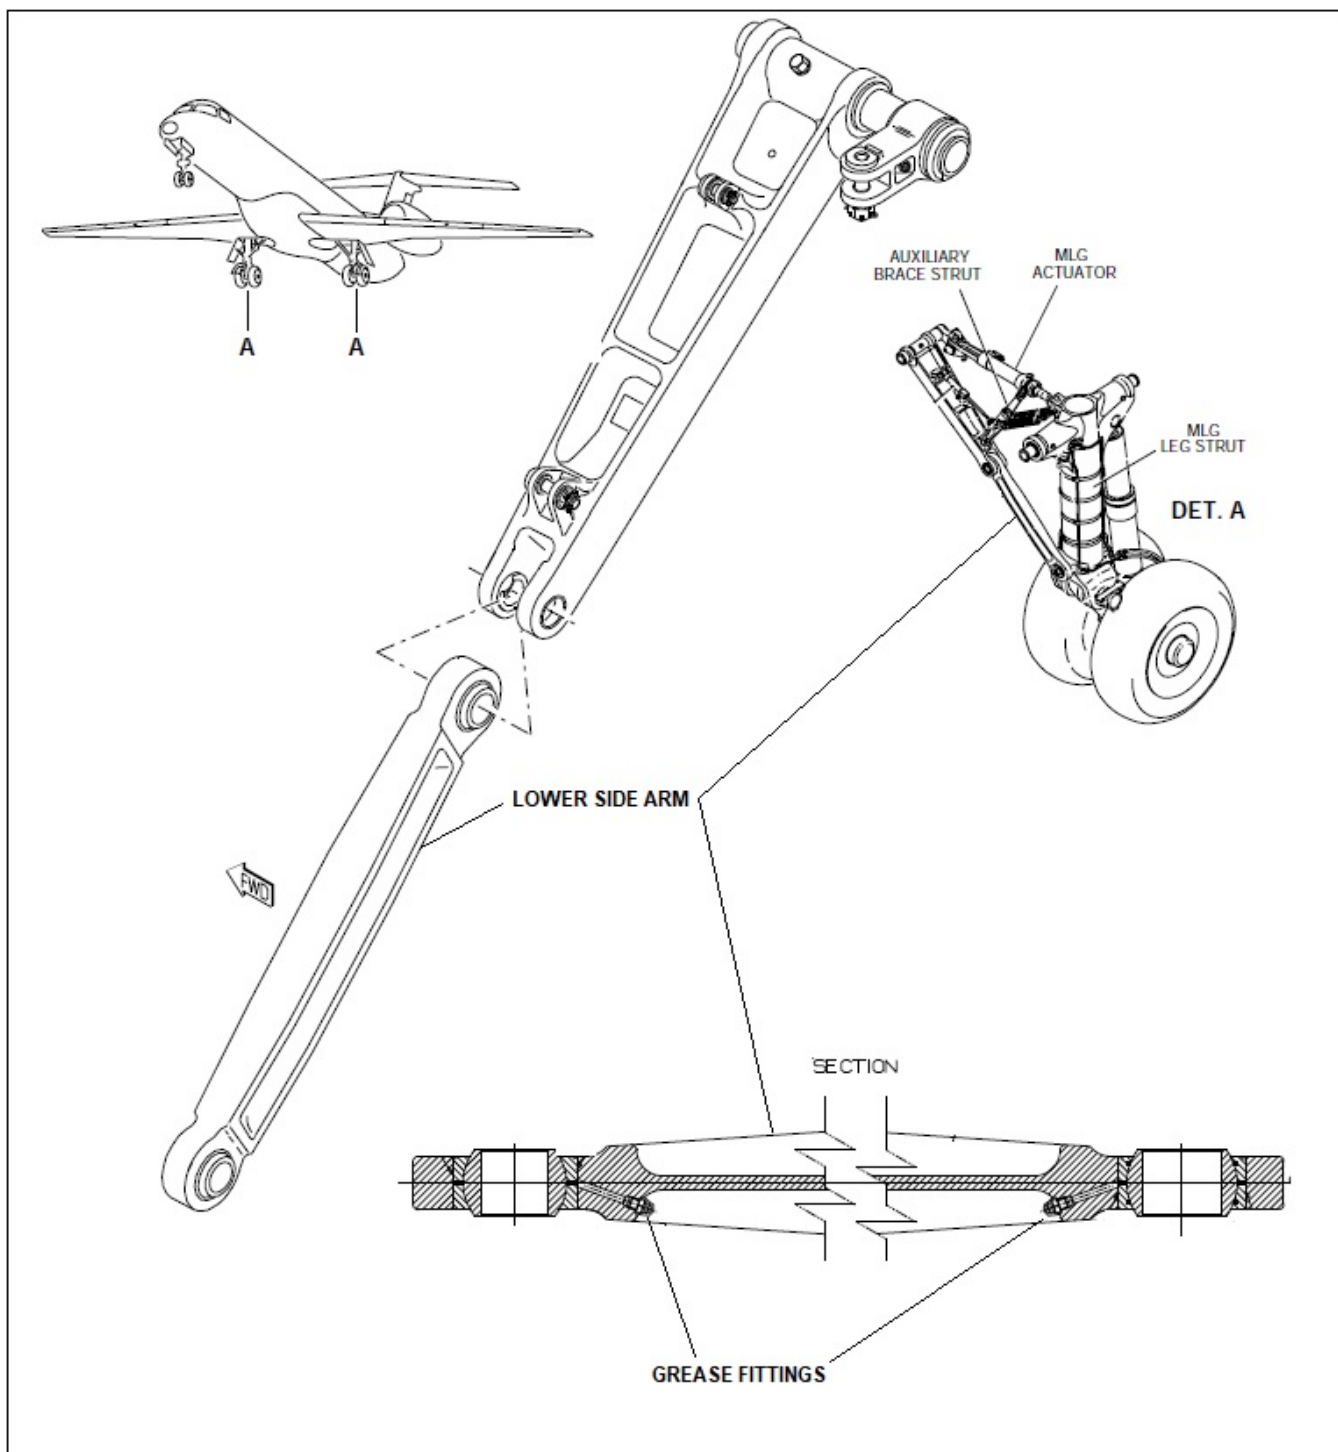
Figure 1: MLG Lower Side Arm correct grease fittings installation

The inspection revealed one occurrence of an MLG Lower Side Arm installed on an aircraft possessing grease fittings on both of its sides. This is not an approved configuration as the MLG Lower Side Arm must have both of its grease fittings installed on the same side (see Figure 1 below).

An MLG Lower Side Arm with grease fittings on both of its sides could lead to a misinterpretation of the MLG assembly instructions which could culminate in an inverted installation of the MLG Side Arm Strut Bearings since the grease fittings installation side on the Lower Side Arm are used as a reference to the correct installation of the Bearings.

A one-time inspection, and replacement of the MLG Lower Side Arm by a serviceable part (see NOTE 1), if necessary, as to the correct positioning of the grease fittings (see Figure 1).

NOTE 1: A serviceable MLG Lower Side Arm (P/Ns 2309-2510-501, or 2309-2510-503, or 2309-2510-505) is one that has both grease fittings installed on the same side of the part (see Figure 1).

1. Verify that both grease fittings are installed on the same side of the MLG Lower Side Arm and that both are facing the flight direction;
 - i. If, during the inspection required by item (a)(1) above, it is found that the grease fittings are installed on opposite sides of the MLG Lower Side Arm (one grease fitting on one side and the other on the opposite side), before the next flight (see NOTE 2), replace the MLG Lower Side Arm by a serviceable part (see NOTE 1). To comply with this paragraph, refer to procedure 32-10-03/400 (MAIN-LANDING-GEAR MAIN BRACE STRUT - REMOVAL/INSTALLATION) of the AMM applicable to the aircraft, and to the CMM (Component Maintenance Manual), procedure T.P. 145/1190_32-10-03, as necessary;

- ii. If, during the inspection required by item (a)(1) above, it is found that both grease fittings are facing opposite to the flight direction, before the next flight (see NOTE 2), remove the Lower Side Arm and re-install it on the correct position (both grease fittings facing the flight direction – see Figure 1). To comply with this paragraph, refer to procedure 32-10-03/400 (MAIN-LANDING-GEAR MAIN BRACE STRUT - REMOVAL/INSTALLATION) of the AMM applicable to the aircraft, and to the CMM (Component Maintenance Manual), procedure T.P. 145/1190_32-10-03, as necessary.

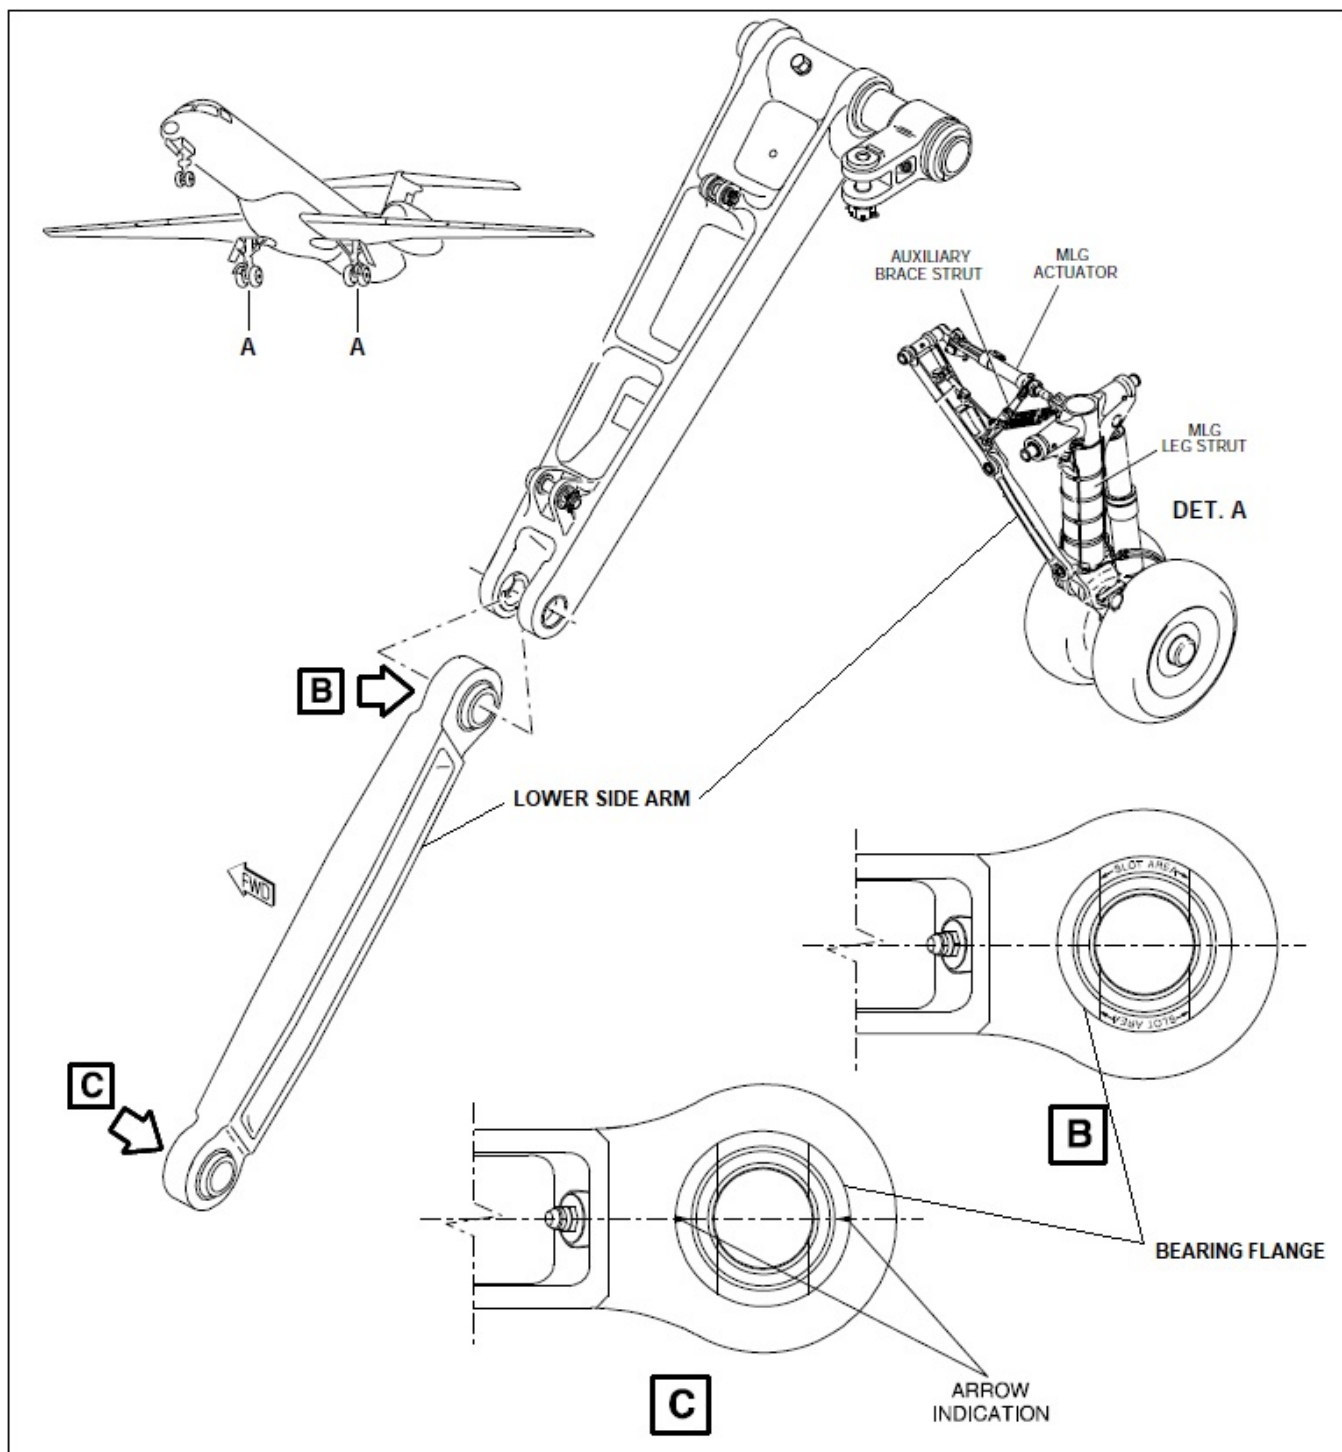
Figure 2: Correct installation of the Lower Side Arm Bearings

On July 2020, there was an incident involving a disconnection of a Side Arm Strut from the right Main Landing Gear in an EMB-145 model aircraft. During the subsequent investigation it was found that the MLG Side Arm Strut Lower Bearing was installed inverted in the aircraft.

It was determined that the inverted installation of the MLG Side Arm Strut Bearing was a contributing factor to the disconnection of the Side Arm Strut from the Main Landing Gear.

2. Verify that the flanges of the 2 MLG Side Arm Bearings are both facing the flight direction (see Details B and C in Figure 2 below);

A one-time inspection, and reinstallation of the MLG Side Arm Strut, if necessary, as to the inverted installation of the Bearings (see Figure 2).

- i. If, during the inspection required by item (a)(2) above, it is found that either of the Bearing's flanges is installed inverted (flange facing opposite to the flight direction), before the next flight (see NOTE 2), remove the Lower side Arm and re-install the affected Bearing in the correct position (flange facing the flight direction). To comply with this paragraph, refer to procedure 32-10-03/400 (MAIN-LANDING-GEAR MAIN BRACE STRUT - REMOVAL/INSTALLATION) of the AMM applicable to the aircraft, and to the CMM (Component Maintenance Manual), procedure T.P. 145/1190_32-10-03, as necessary.
3. Verify that there is no migration of both Bearings of the MLG Side Arm (see Details B and C in Figure 2) (both Flanges shall be flushed with the MLG Lower Side Arm face);
