適航指令發布單
Airworthiness Directive Issuance Form

No. TCD-8201C-2-2022

Airworthiness Directive

1. Applies to: Kawasaki BK117 series helicopters equipped with a Goodrich rescue hoist assembly having a Part Number (P/N) as listed in Table 2.1 of this AD.

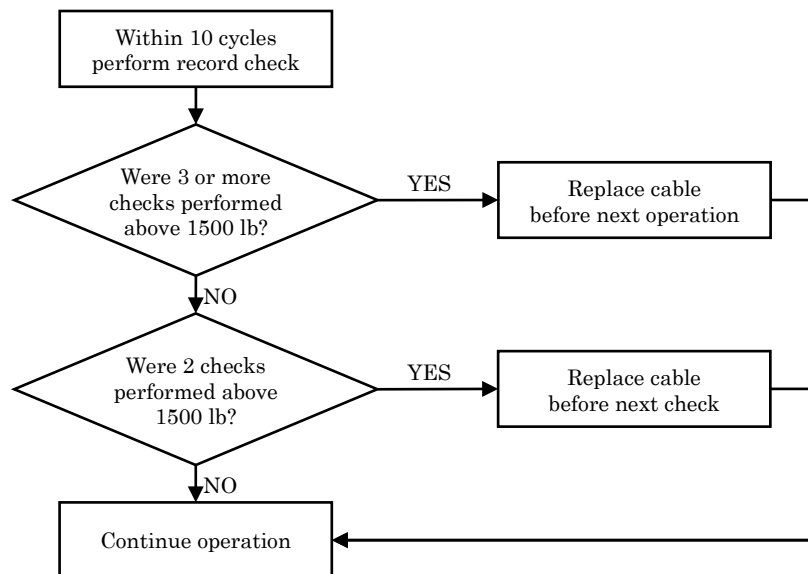
2.1 Within 10 hoist operating cycles from June 17, 2016 (the effective date of AD No. TCD-8201C-2016), accomplish a records check to determine whether, during any previous hoist load check/test, a cable was load-tested (average of 5 pulls) at 1500 lb [680 kg] or more. If any cable is identified to have exceeded this limit during two or more hoist load checks/tests, replace the affected cable with a serviceable cable within the time interval shown in paragraph 2.1.1 or 2.1.2 of this AD. For replacement of a cable, see Figure 1 of this AD.

Japan Civil Aviation Bureau	No. TCD-8201C-2-2022	sheet 6/6
<p>is acceptable to install a replacement cable on a hoist / helicopter, provided that, prior to installation, it is determined that the cable was not previously load-tested at 1500 lb (680 kg) or more.</p> <p>2.12 An alternative means of compliance with this AD may be used, if approved by the Director-General of JCAB.</p>		
<p>3. Remarks</p> <p>3.1 This AD becomes effective on January 5, 2023.</p> <p>3.2 This AD revises a part of the AD No. TCD-8201C-1-2022 dated July 28, 2022. The revised part corresponds to the underlined part, the part which is not underlined is non-revised part. Therefore, regarding non-revised part, execute the inspection, the repair, the exchange, the modification, etc. in the compliance time which is indicated on pre-revised AD.</p> <p>3.3 If there is any difficulty to insert applicable attachment to RFM(S), contact JCAB for further information.</p> <p>3.3 Kawasaki Service Bulletin No. KSB-117-361F dated May 23, 2016, No. KSB-117-361G dated July 12, 2022 and No. KSB-117-361H dated December 6, 2022 and later JCAB approved revisions pertain to this subject.</p>
