適航指令發布單

民航局 AD 編號 AD number	CAA-2023-09-001	發布日期 Date issued	2023/9/5
適用之航空產品 Applied to (models, serial numbers or part numbers, as applicable)	This AD applies to all The Boeing Company Model 777-200, -200LR, -300, -300ER, and 777F series airplanes, certificated in any category, excluding the airplanes identified in paragraphs (c)(1) and (2) of this AD. (1) Boeing Model 777-200 series airplanes having a maximum taxi weight equal to or less than 547,000 pounds. (2) Boeing Model 777F series airplanes with manufacturer line numbers of 1743 and subsequent.		
主旨摘要 Subject	This AD retains the actions required by AD 2022-18-11(CAA-2022-09-012), and requires a maintenance records review of previously modified airplanes for the procedures used during that modification, and applicable corrective actions.		
民航局 CAA <input type="checkbox"/> 本國產品 Native product <input type="checkbox"/> 其他個案 Other	設計國民航主管機構 Original Authority <input checked="" type="checkbox"/> FAA <input type="checkbox"/> Germany LBA <input type="checkbox"/> EASA <input type="checkbox"/> CAA-NL <input type="checkbox"/> Brazil <input type="checkbox"/> UK CAA <input type="checkbox"/> Transport Canada Civil Aviation <input type=

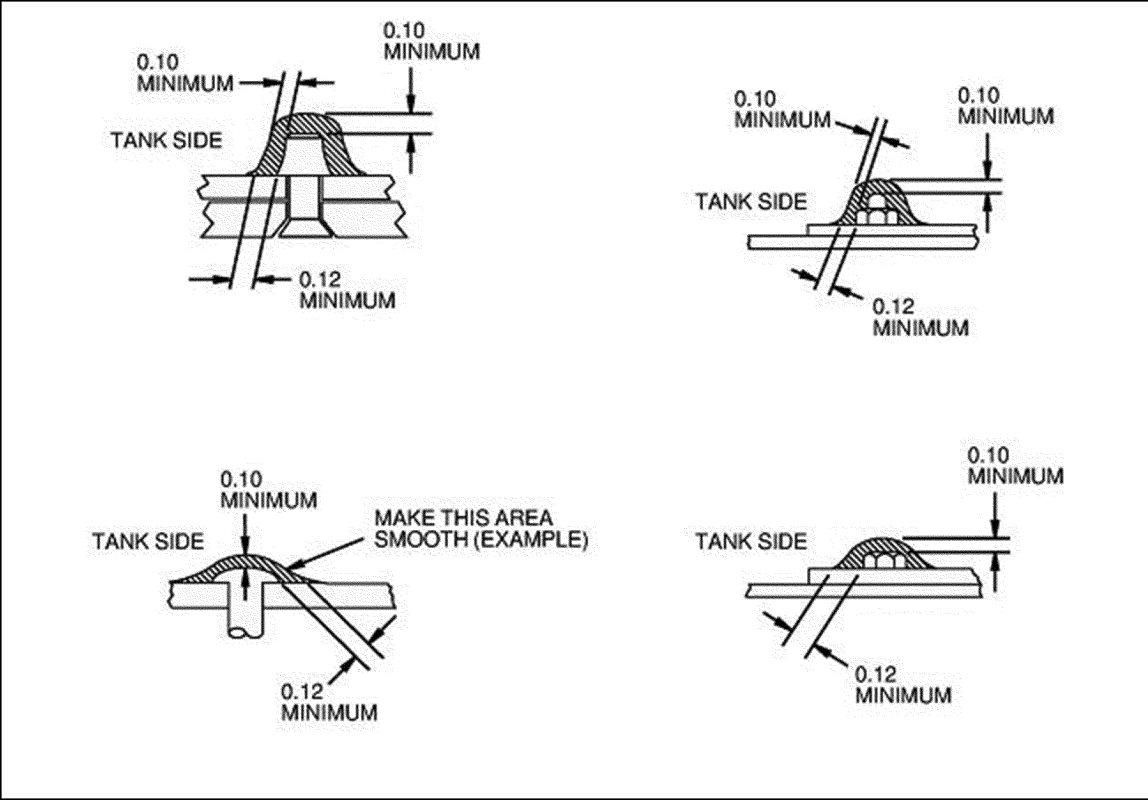
Figure 1 to paragraph (h)(4) — Cap seal minimum thickness (all dimensions in inches)

Second, certain other groups and configurations have no thickness requirement for the applied cap seal, and the requirements bulletin mistakenly refers to the Boeing Standard Overhaul Practices Manual (SOPM) section 20-50-19 for procedures to apply the cap seal. The SOPM procedure specifies a thickness that is half the necessary thickness, while the Boeing Model 777 aircraft maintenance manual (AMM) procedure, which is also referred to in the requirements bulletin, specifies the correct thickness for cap seals. It is also possible that operators may have used an accepted method other than that specified in the SOPM and AMM, as no specific procedure was required by the requirements bulletin. A cap seal of insufficient thickness may fail to contain a spark resulting from a lightning strike, similarly compromising the fault tolerance of the fuel tank lightning protection. This AD specifies the minimum thickness and sealant type for an applied cap seal, and requires replacement of any seal that was previously applied using a procedure that specifies an inadequate thickness.

- (4) During application of any cap seal to a fastener, fastener head, and fastener threads and collars, as required by this AD, the cap seal must be applied with a thickness equal to or greater than the dimensions specified in figure 1 to paragraph (h)(4) of this AD.

(ii) All cap seals were applied using procedures with thickness dimensions greater than or equal to those given in figure 1 to paragraph (h)(4) of this AD.

(2) If any cap seal was applied using procedures with thickness dimensions less than those given in figure 1 to paragraph (h)(4) of this AD, or if the maintenance records do not definitively specify the procedures used: At the applicable time specified in paragraph (i)(2)(i) or (ii) of this AD, replace the cap seal in accordance with the Accomplishment Instructions of Boeing Alert Requirements Bulletin 777-57A0122 RB, dated October 8, 2021, using a cap sealing procedure with thickness greater than or equal to the dimensions given in figure 1 to paragraph (h)(4) of this AD.
