# 適航指令發布單

民航局AD編號 AD number	CAA-2024-04-001	發布日期 Date issued	2024/04/10
適用之航空產品 Applied to (models, serial numbers or part numbers, as applicable)	ATR 42-400 and ATR 42-500 aeroplanes, all manufacturer serial numbers (MSN) ; and ATR 72-101, ATR72-102, ATR 72-201, ATR 72-202, ATR 72- 211, ATR 72-212 and ATR 72-212A aeroplanes, all MSN.		
主旨摘要 Subject	Flight Controls - Rudder Travel Limiting Unit - Inspection		
民航局 CAA  <input type="radio"/> 本國產品 Native product  <input type="radio"/> 其他個案 Other	設計國民航主管機構 Original Authority  <input type="radio"/> FAA <input type="radio"/> Germany LBA <input checked="" type="radio"/> EASA <input type="radio"/> CAA-NL <input type="radio"/> Brazil <input type="radio"/> UK CAA <input type="radio"/> Transport Canada Civil Aviation <input type="radio"/> Japan CAB <input type="radio"/> DGAC <input type="radio"/> CAA of Israel <input type="radio"/> Other_____		
	設計國AD編號 Original AD number	2024-0081

**AD No.:** 2024-0081

### ATA 27 – Flight Controls – Rudder Travel Limiting Unit – Inspection

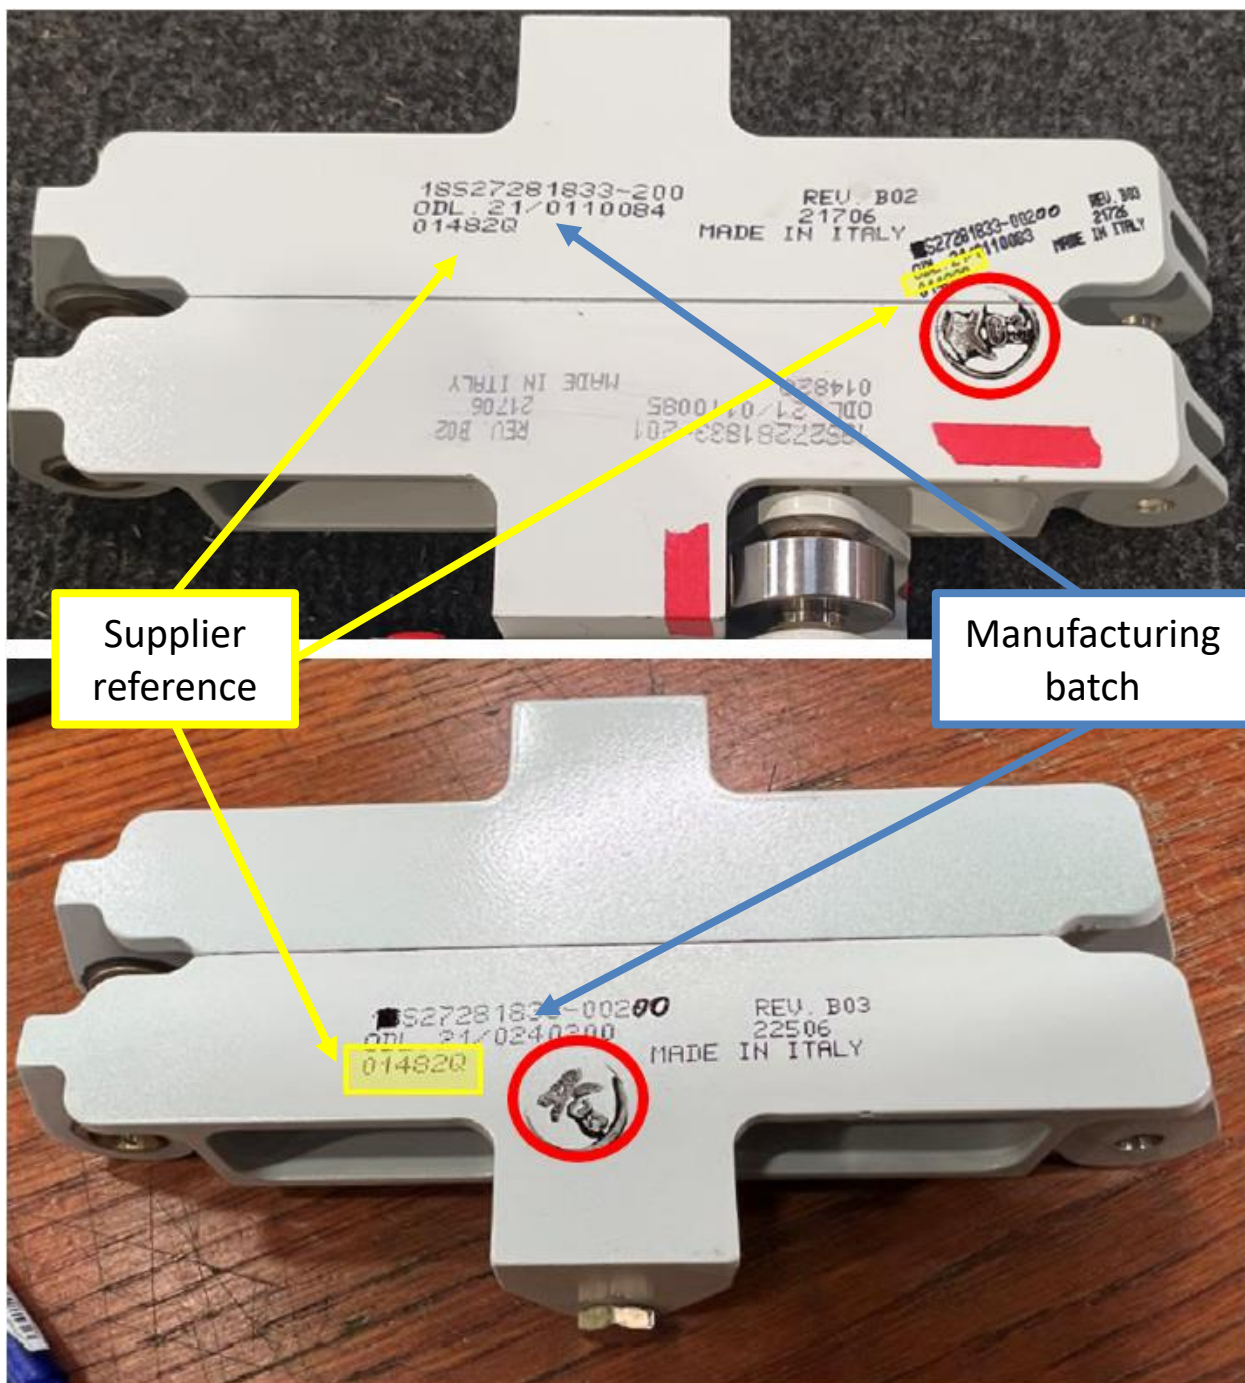
## APPENDIX 1 - TLU supplier code and manufacturing batch identification

Note 1: The supplier code and the manufacturing batch of the TLU lever can be identified directly on the part; an example is provided in Appendix 1 of this AD.
