民航局AD編號 AD number	CAA-2024-05-005	發布日期 Date issued	2024/05/10
適用之航空產品 Applied to (models, serial numbers or part numbers, as applicable)	ATR 42-400 and ATR 42-500 aeroplanes, all manufacturer serial numbers (MSN) ; and ATR 72-101, ATR 72-102, ATR 72-201, ATR 72-202, ATR 72-211, ATR 72-212 and ATR 72-212A aeroplanes, all MSN.		
主旨摘要 Subject	Flight Controls - Rudder Travel Limiting Unit - Inspection		
民航局 CAA <input type="radio"/> 本國產品 Native product <input type="radio"/> 其他個案 Other	設計國民航主管機構 Original Authority <input type="radio"/> FAA <input type="radio"/> Germany LBA <input checked="" type="radio"/> EASA <input type="radio"/> CAA-NL <input type="radio"/> Brazil <input type="radio"/> UK CAA <input type="radio"/> Transport Canada Civil Aviation <input type="radio"/> Japan CAB <input type="radio"/> DGAC <input type="radio"/> CAA of Israel <input type="radio"/> Other_____		
	設計國AD編號 Original AD number	2024-0096

AD No.: 2024-0096

ATR 42 and ATR 72 aeroplanes

ATA 27 – Flight Controls – Rudder Travel Limiting Unit – Inspection

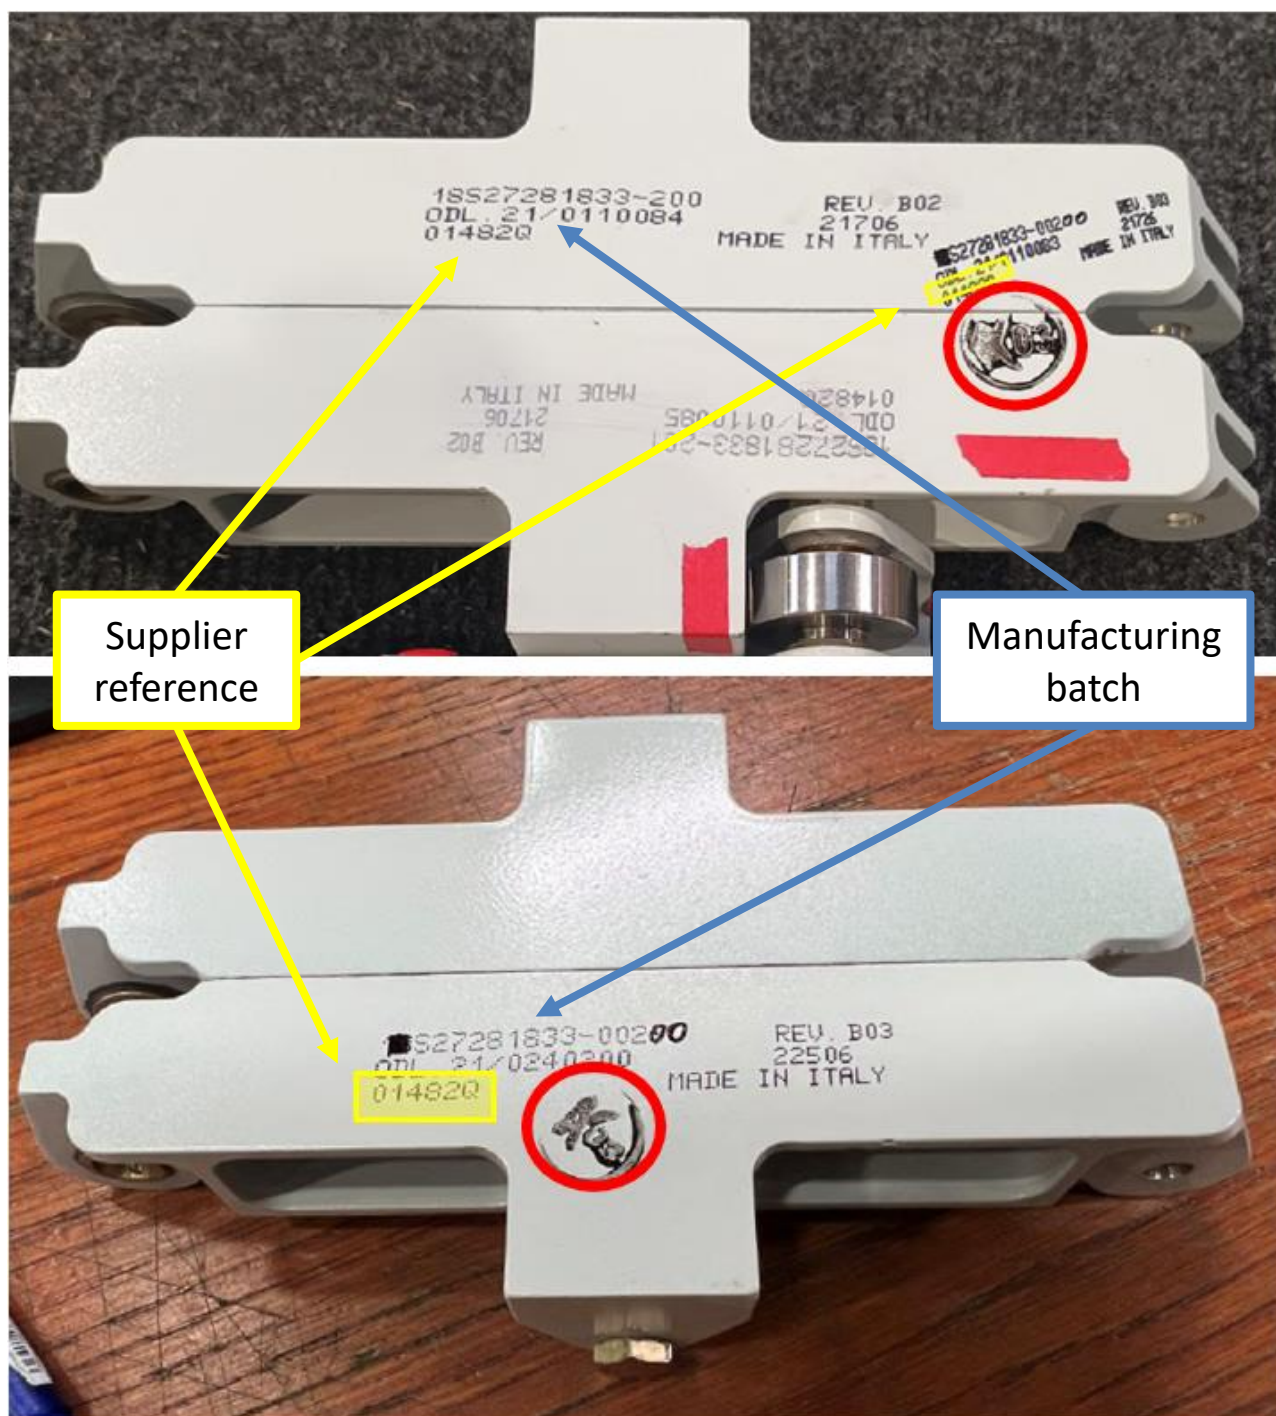
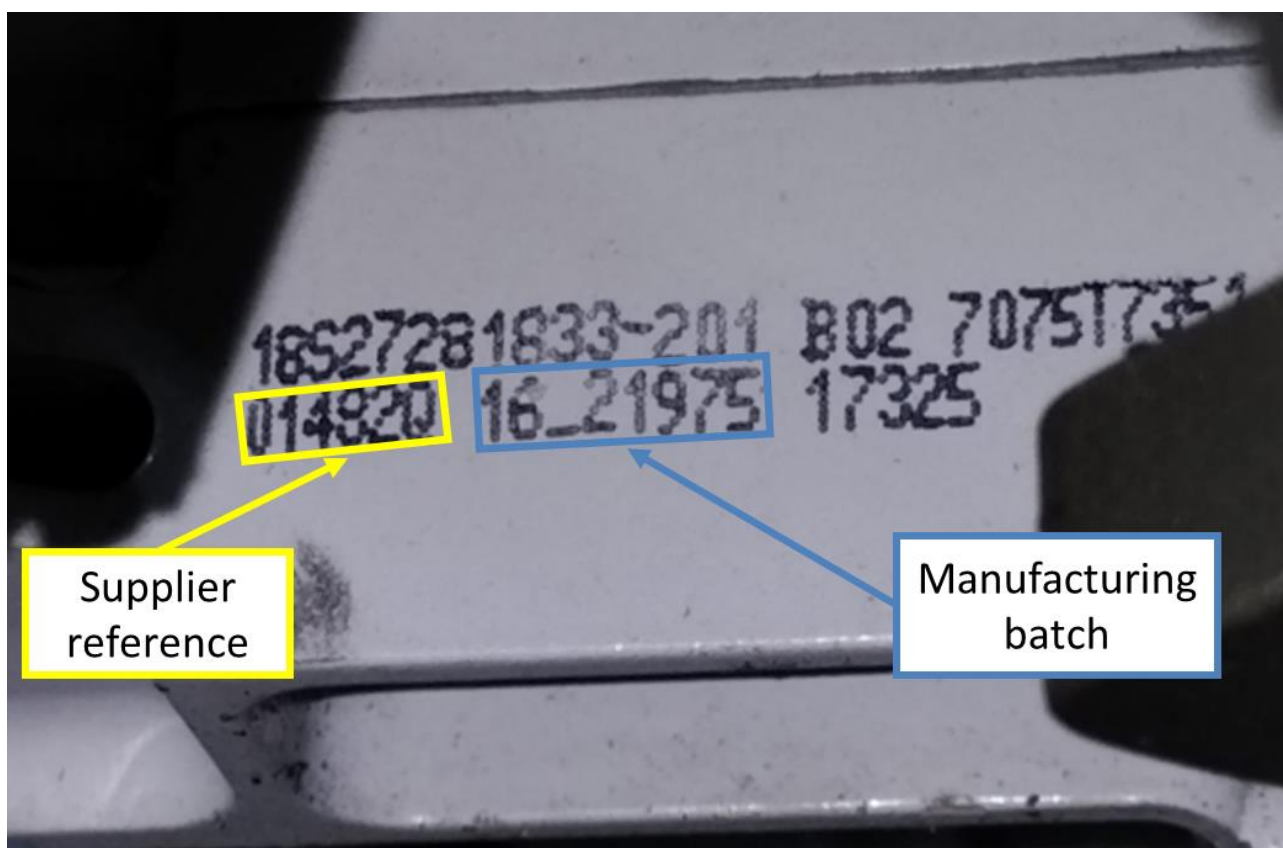
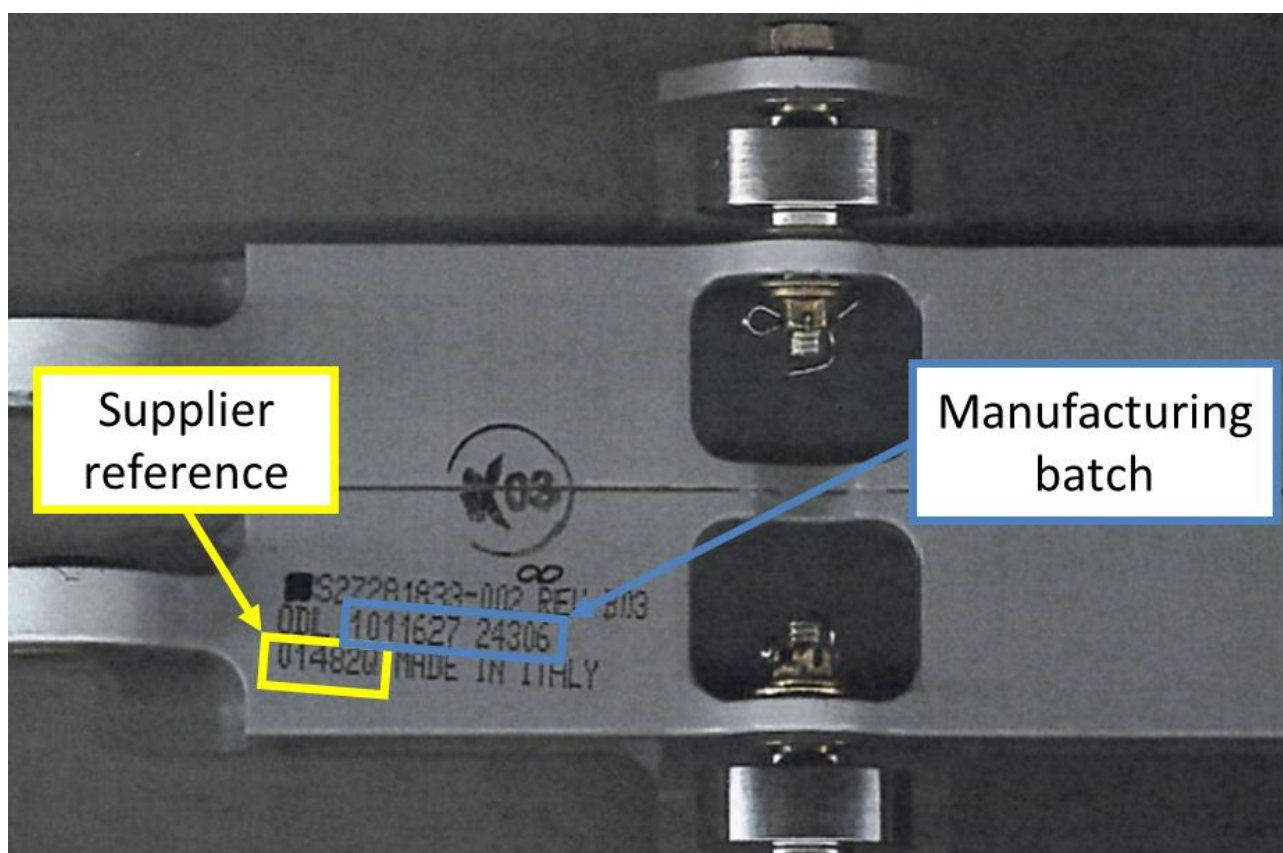
Appendix 1 - TLU Supplier Code and Manufacturing Batch Identification

- Part Number (P/N) S2728183300200 or P/N 18S27281833900, and
- a supplier code equal to **01482Q** (see Note 1 of this AD), or without supplier code, or a supplier code which is not readable, and
- manufacturing batch:
 - between **16/0000000** and **24/1011628** exclusive, or

- between **16_00000** and **24_1011628** exclusive, or
- between **0000000 24XXX** and **1011628 24XXX** exclusive (where 'XXX' represents any numerical sequence), or without a batch number, or with a batch number that is not readable,

Note 1: The supplier code and the manufacturing batch of the TLU lever can be identified directly on the part; an example is provided in Appendix 1 of this AD.
