適航指令發布單

AD No.: 2024-0119

A330 aeroplanes

ATA 26 – Fire Protection – Engine Pylon Fire Detector – Replacement

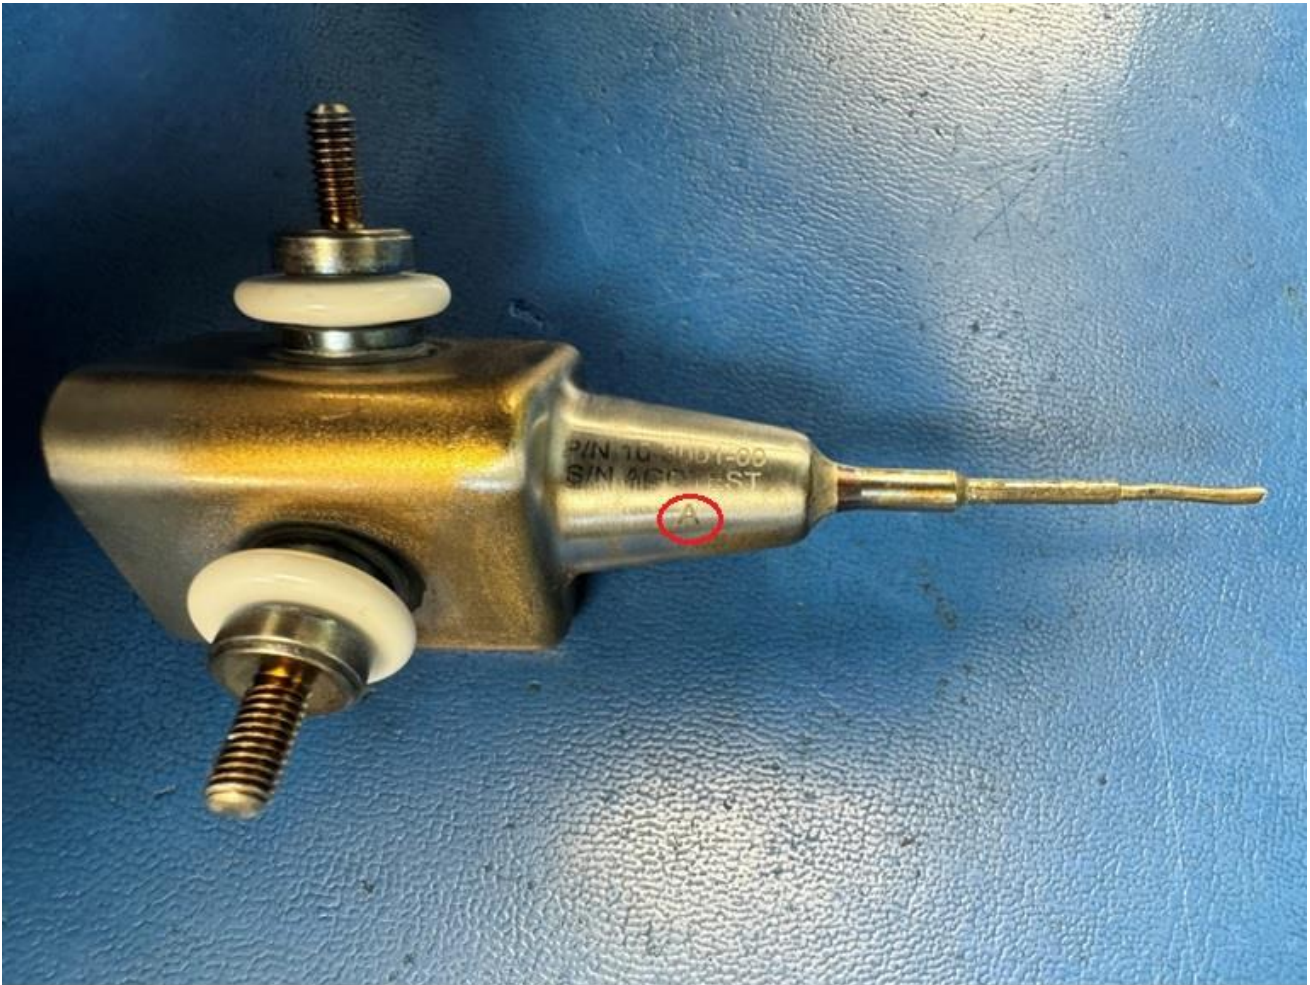
Note 1: The engraved 'A' is in addition to the 'A' part of the s/n of an affected part (i.e. AExxxxx). Refer to Appendix 1 of this AD, showing the typical location of the engraved 'A'.

Marking of Parts
