# 適航指令發布單 Airworthiness Directive Issuance Form

民航局AD編號 AD number	CAA-2024-10-003	發布日期 Date issued	2024/10/14												
適用之航空產品 Applied to (models, serial numbers or part numbers, as applicable)	This AD applies to The Boeing Company Model 777-200, -200LR, -300, -300ER, and 777F series airplanes, certificated in any category, as identified in Boeing Alert Requirements Bulletin 777-53A0100 RB, dated March 16, 2023.														
主旨摘要 Subject	This AD requires external or internal (depending on configuration) inspections for any cracking of the left and right side fuselage skin common to the UWL, and applicable on-condition actions.														
民航局 CAA  <input type="radio"/> 本國產品 Native product  <input type="radio"/> 其他個案 Other	設計國民航主管機構 Original Authority

### **Airworthiness Directives; The Boeing Company Airplanes**

**2024-16-09 The Boeing Company:** Amendment 39-22815; Docket No. FAA-2024-0769; Project Identifier AD-2023-00556-T.

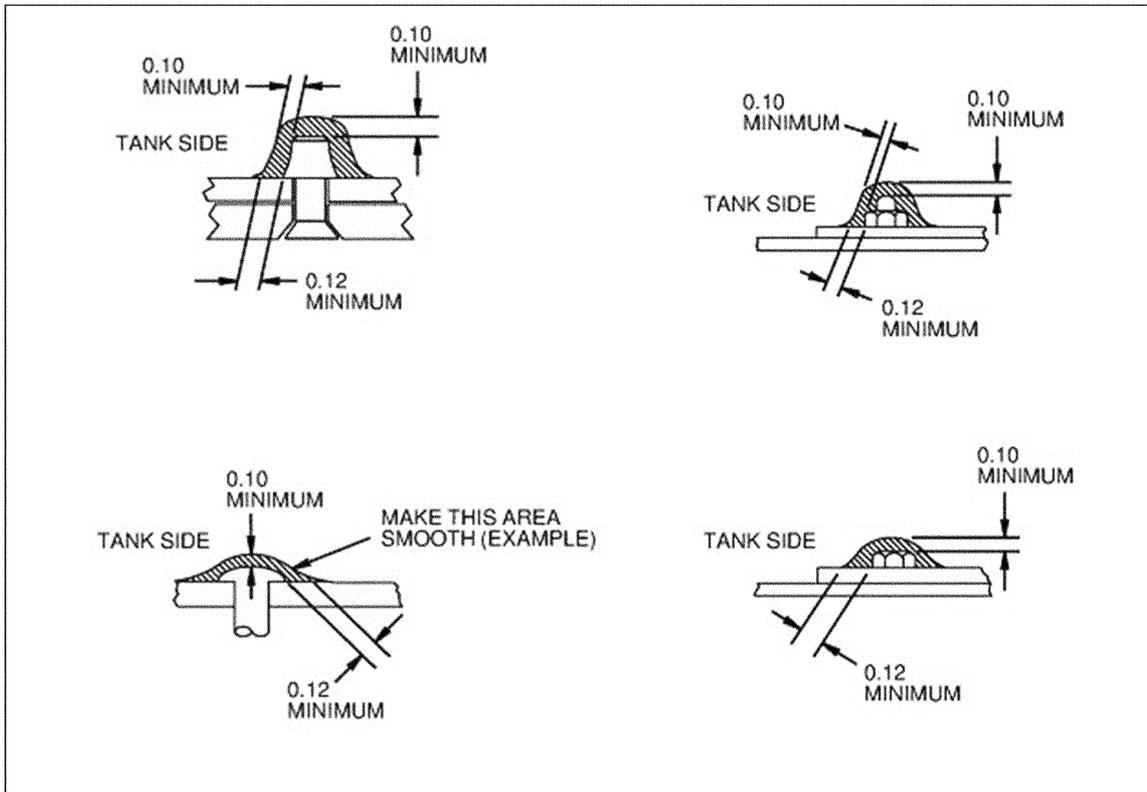
**Figure 1 to Paragraph (h)(3)—Cap Sealing Dimensions (all Dimensions are in Inches)**

Boeing concluded that only the cap seals on the interior side of the fuel tank require the dimensions specified in Figure 1 of paragraph (h)(3) of the proposed AD to perform their intended function, which is consistent with the labels shown in Figure 1 of paragraph (h)(3) of the proposed AD. Boeing recommended replacing the text “applying a cap seal (sealant) to a fastener, fastener head, and fastener threads and collars, for this AD, during application of any cap seal to a fastener, fastener head, or fastener threads and collars” with the text “applying a cap seal (sealant) to a fastener location that penetrates the fuel tank boundary, for this AD, during application of any cap seal to a fastener, fastener head, or fastener threads and collars inside the fuel tank.”

The FAA agrees. Boeing 777 AMM 28-11-00 meets the sealant requirements of Figure 1 to paragraph (h)(3) of this AD. As such, it would be an acceptable procedure to follow when sealing inside the fuel tank in accordance with paragraph (h)(3) of this AD. The FAA has added a note to paragraph (h)(3) of this AD accordingly.

(3) Where any service information referenced in Boeing Alert Requirements Bulletin 777-53A0100 RB, dated March 16, 2023, specifies applying a cap seal (sealant) to a fastener, fastener head, and fastener threads and collars inside the fuel tank, for this AD, during application of any cap seal to a fastener, fastener head, or fastener threads and collars inside the fuel tank, the cap seal must be

applied using a cap sealing procedure with thickness greater than or equal to the dimensions given in Figure 1 to paragraph (h)(3) of this AD.
