# 適航指令發布單

**AD No.:** 2024-0196

A318, A319, A320 and A321 aeroplanes

### ATA 36 – Pneumatic – Overheat Detection System Sensing Elements – Inspection

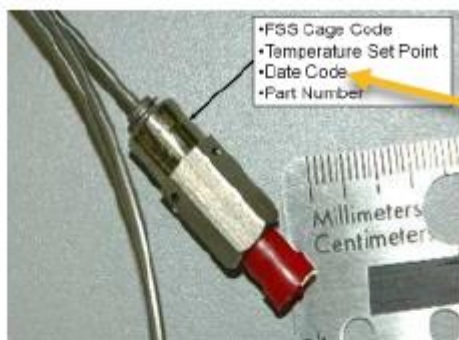
Figure 4-50. Identification Markings on Coaxial SE Male (Pin) Connector

## Appendix 1 – Affected Part – Locations of P/N and Date Code
