# 適航指令發布單

## Airworthiness Directive Issuance Form

## Airworthiness Directive

**AD No.:** 2024-0221

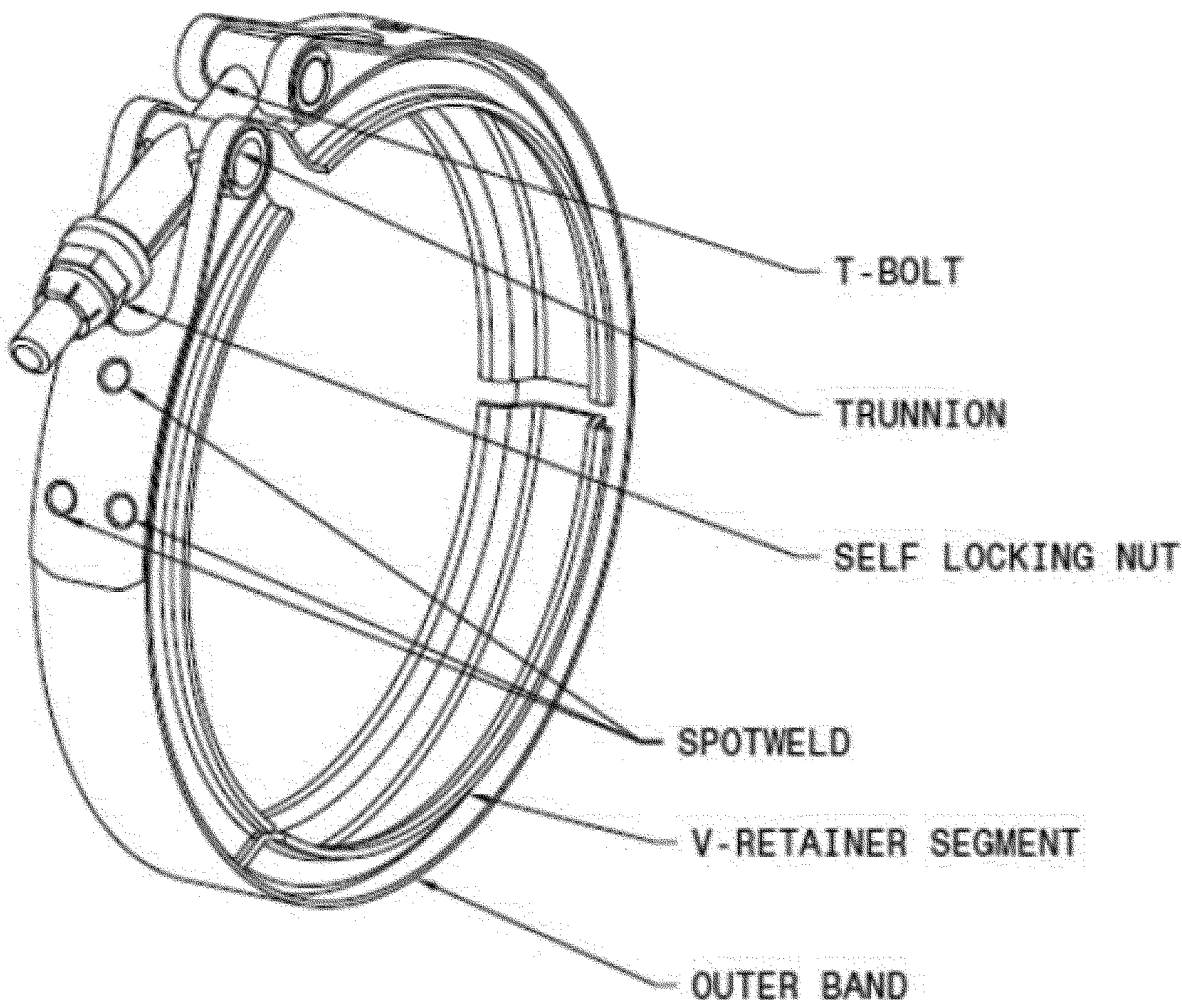
Figure 1 – Spot-Welded, Multi-Segment Exhaust Tailpipe V-Band Coupling

**Affected part:** Spot-welded, multi-segment v-band couplings installed at the tailpipe of the turbocharger exhaust housing flange.

Failures have been reported of spot-welded, multi-segment v-band couplings, installed at the tailpipe to the turbocharger exhaust housing flange. Over the years, this has resulted in a significant number of incidents and accidents (fatal and non-fatal) on both aeroplanes and helicopters. To address this safety subject, the FAA has issued multiple ADs (listed in Appendix 2 of this AD) for specific type designs, as well as several Special Airworthiness Information Bulletins (SAIB).

Since those actions, the FAA constituted a working group to study v-band coupling failures associated with turbocharged reciprocating engine-powered aircraft depending on each specific coupling type (spot-welded, riveted, or single piece). The working group's final report determined that riveted couplings are not affected by a safety concern, and concluded that the common denominator in the incidents and accidents reviewed is the spot-welded, multi-segment exhaust tailpipe v-band coupling (see Figure 1 of this AD). These couplings come in either two or three segment varieties. The segments are the number of v-retainer segments, which are attached to the outer band via spot welds. The majority of the events studied by the working group indicated fatigue failure of affected parts as a result of stress corrosion cracking that originated at or near a spot weld.

This condition, if not detected and corrected, could lead to failure of the affected part, leading to detachment of the exhaust tailpipe from the turbocharger and allowing high-temperature exhaust gases to enter the engine compartment, possibly resulting in smoke in the cockpit, in-flight fire, and loss of control of the aircraft.

- (2) For Group 1 aircraft: Within the compliance times specified in Table 1 of this AD, and, thereafter, at intervals not to exceed 500 FH, remove each affected part from service and install a serviceable part, as defined in this AD, and apply correct torque, as applicable, to the affected part nut.

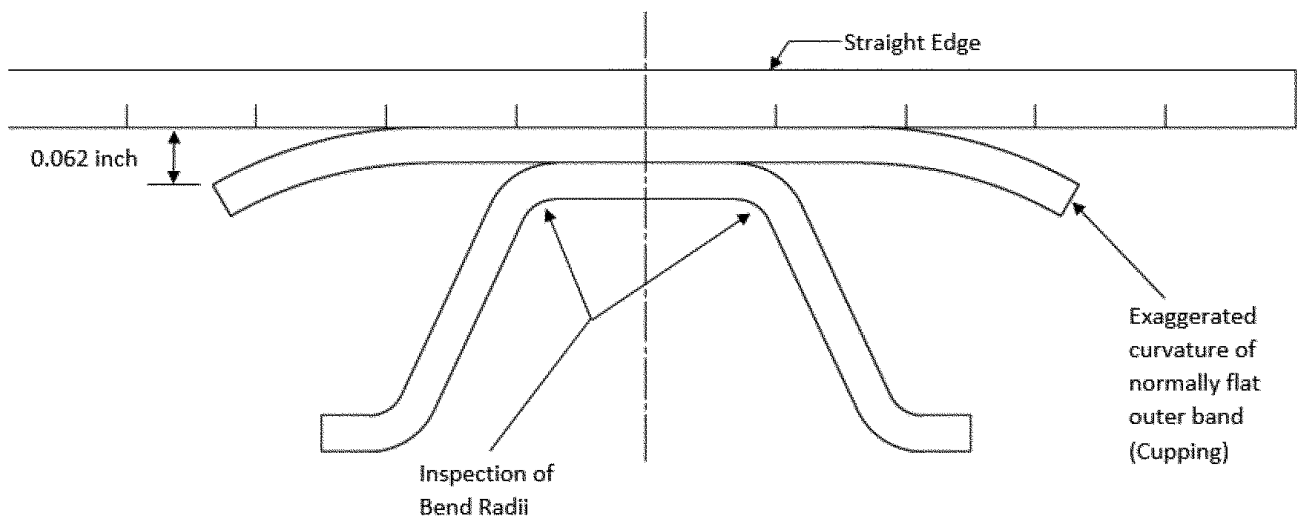
- (a.4) Visually inspect the affected part outer band for cupping, bowing, and crowning as depicted in Figure A3.1 of paragraph (b.4) of this Appendix. If there is any cupping, bowing, or crowning, before next flight, remove the affected part and, instead of the inspections in paragraphs (a.5) through (a.7) of this Appendix, do the inspections in paragraph (b) of this Appendix.

- (b.3) Using a 10X magnifying glass, visually inspect the outer band for cracks, paying particular attention to the spot weld areas. If there is a crack, before next flight, remove the affected part from service and install a serviceable part, as defined in this AD.
- (b.4) Visually inspect the flatness of the outer band using a straight edge. Lay the straight edge across the width of the outer band as depicted in Figure A3.1 of this paragraph. If the gap between the outer band and the straight edge exceeds 0.062 inch (1,575 mm) before next flight, remove the affected part from service and install a serviceable part, as defined in this AD.

- (b.6) Visually inspect the bend radii of the v-retainer coupling segments, throughout the length of the segment, as depicted in Figure A3.1 of paragraph (b.4) of this Appendix, for cracks. If there are any cracks, before next flight, remove the affected part from service and install a serviceable part, as defined in this AD.
- (b.7) Visually inspect the outer band opposite the t-bolt for damage (distortion, creases, bulging, or cracks) caused by excessive spreading of the coupling during installation or removal. If there is any damage, before next flight, remove the affected part from service and install a serviceable part, as defined in this AD.
- (b.8) If any affected part passes all inspections specified in paragraphs (b.2) through (b.7) of this Appendix, it may be re-installed.
