# 適航指令發布單

**AD No.:** 2026-0096

MBB-BK117 helicopters

## ATA – Rotorcraft Flight Manual – Section Emergency Procedures – Amendment ATA 42 – Integrated Modular Avionics – Ethernet Network – Inspection / Modification

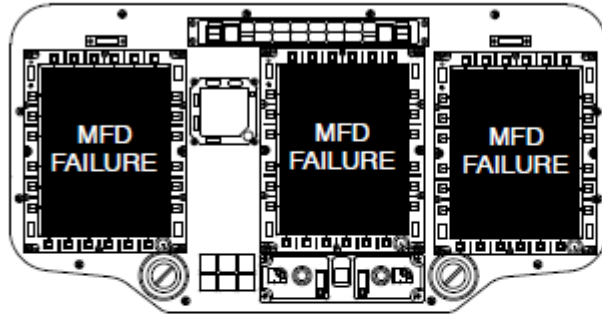
- MFDs:

- MFD FAILURE displayed on all MFDs
- If autopilot upper modes were coupled, they may decouple after 10 seconds (indicated by an „autopilot decouple“ voice message).
