# 適航指令發布單 Airworthiness Directive Issuance Form

**AD No.:** 2026-0176

A318, A319, A320 and A321 aeroplanes

## ATA 92 – Electrical Systems Installation – Battery Retaining Rods – Identification / Replacement

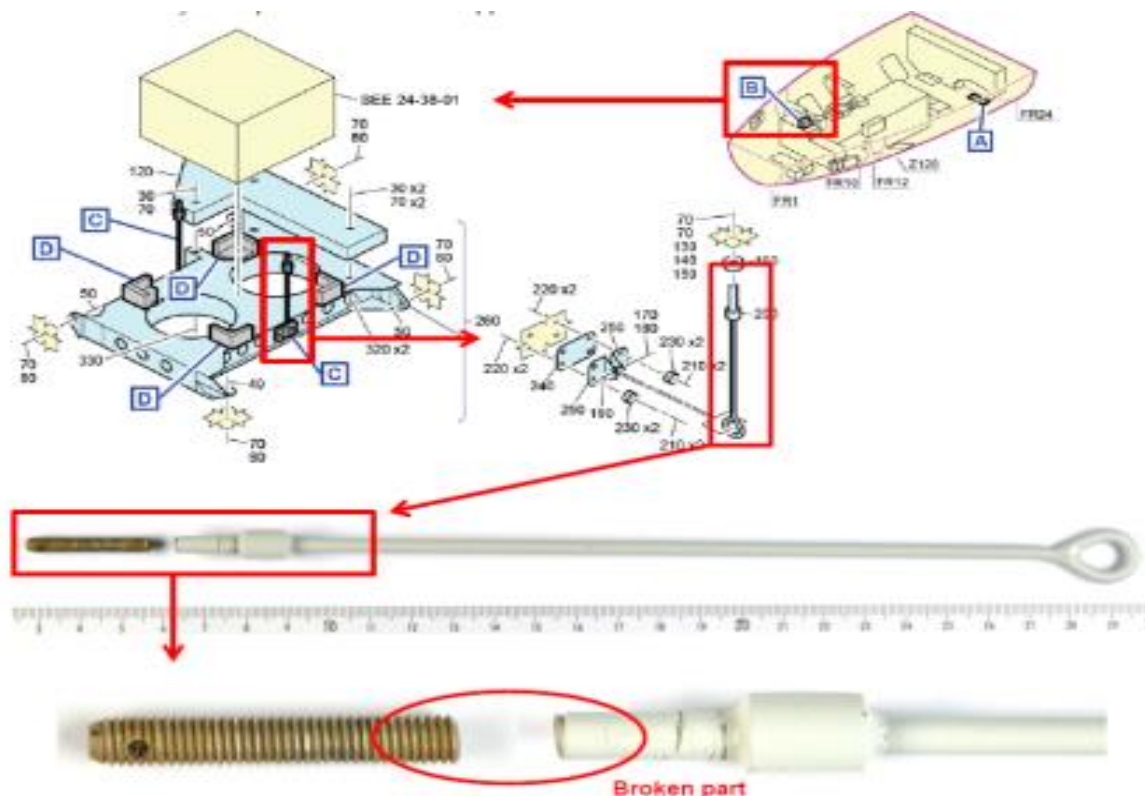
### Shape of battery rod P/N D9241023700000

Note 4: The requirement for identification with a label applies only to rods having P/N D9241023700000. See Appendix 1 of this AD for information about the shape of affected parts.
