適航指令發布單
Airworthiness Directive Issuance Form

設計國AD編號 Original AD number	2026-20-10Correction

[Docket No. FAA-2026-2712; Project Identifier AD-2025-00931-T; Amendment 39-23483; AD 2026-20-10]

Airworthiness Directives; The Boeing Company Airplanes; Correction

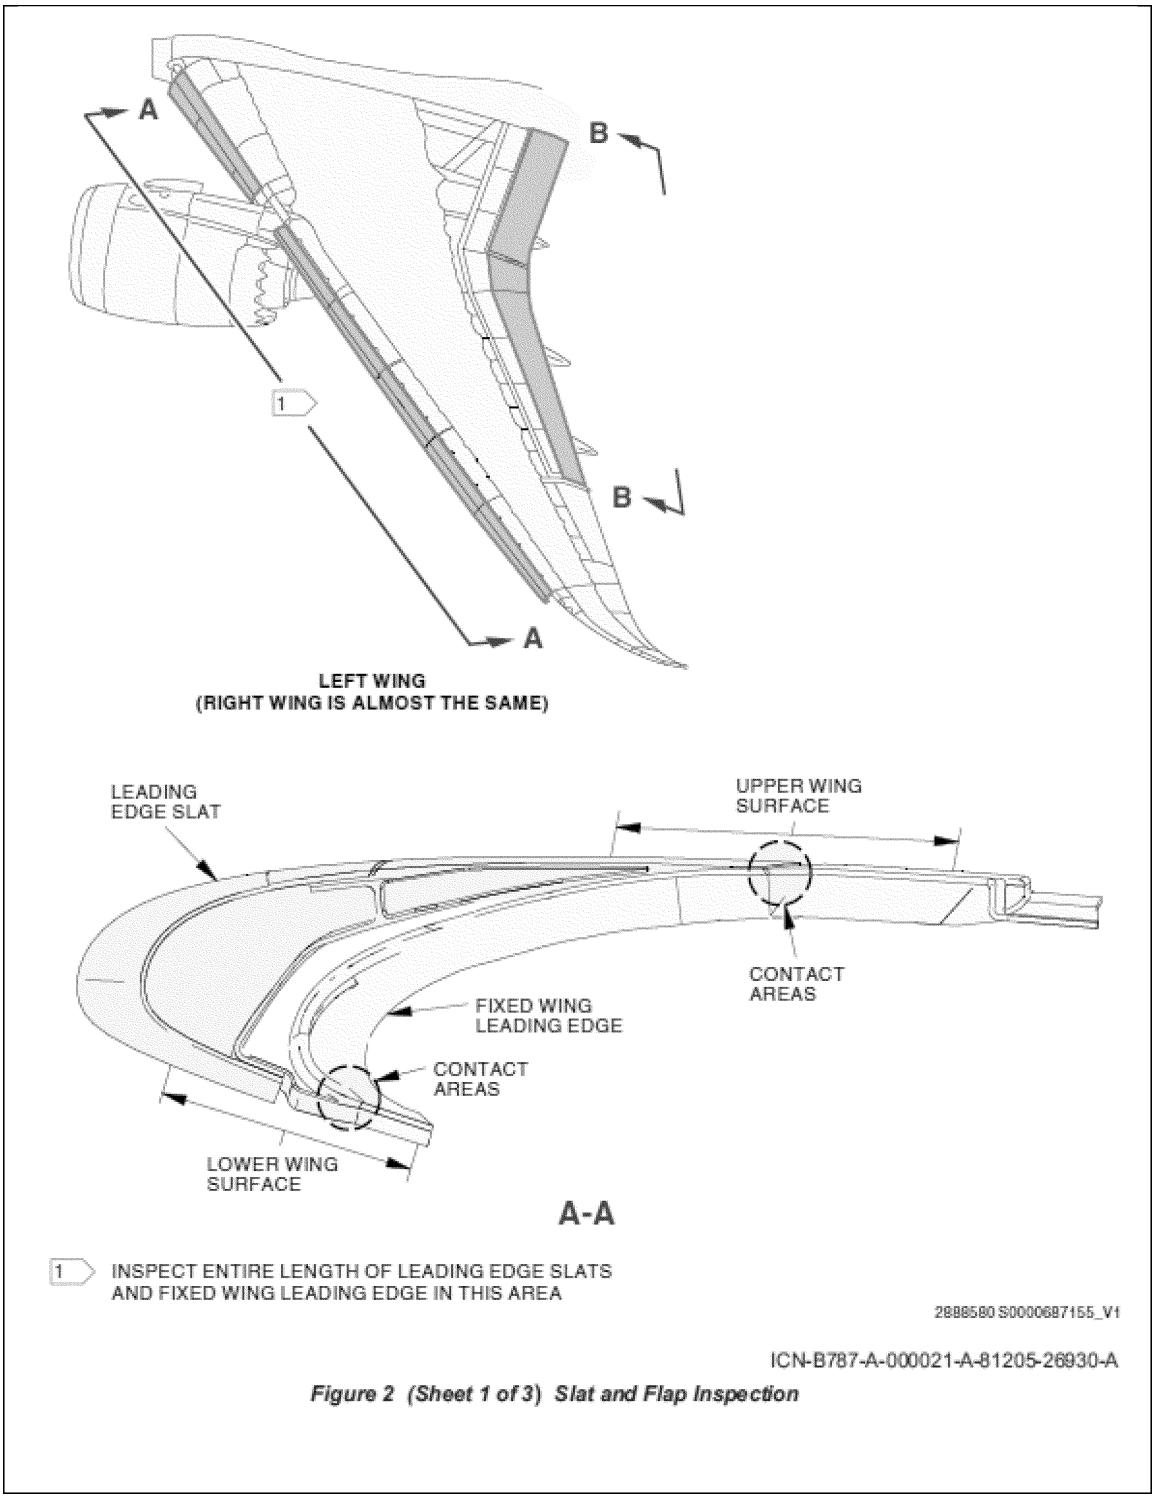
Figure 2 (Sheet 1 of 3) Slat and Flap Inspection

After any landing in icing conditions, do this inspection with the slats/flaps (flaps 25 detent) fully extended (Figure 2):

(a) Examine these areas for contaminants (ice, snow, slush):

(3) Slat actuation areas, including exposed areas of the slat track cavity, and slat cove

(4) Flap tracks, hinges, seals

(b) Remove the contamination that you find.

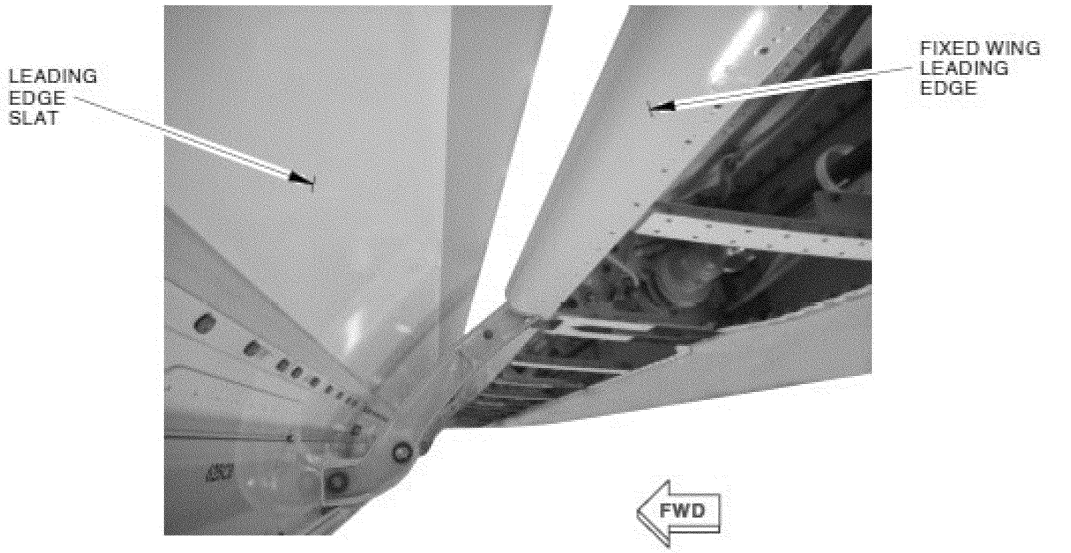
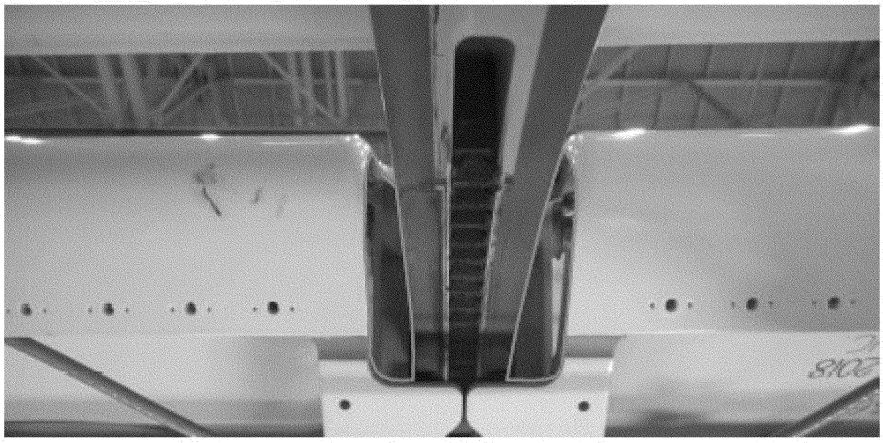
Figure 2 (Sheet 2 of 3) Slat and Flap Inspection

ACTUATION AREAS
(TYPICAL)
A-A

SLAT TRACK CAVITY
(TYPICAL)
(VIEW IN THE AFT DIRECTION)
A-A

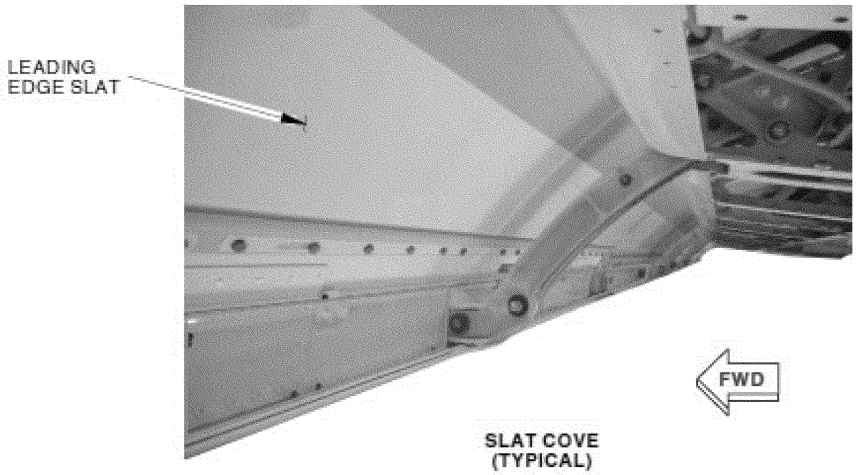
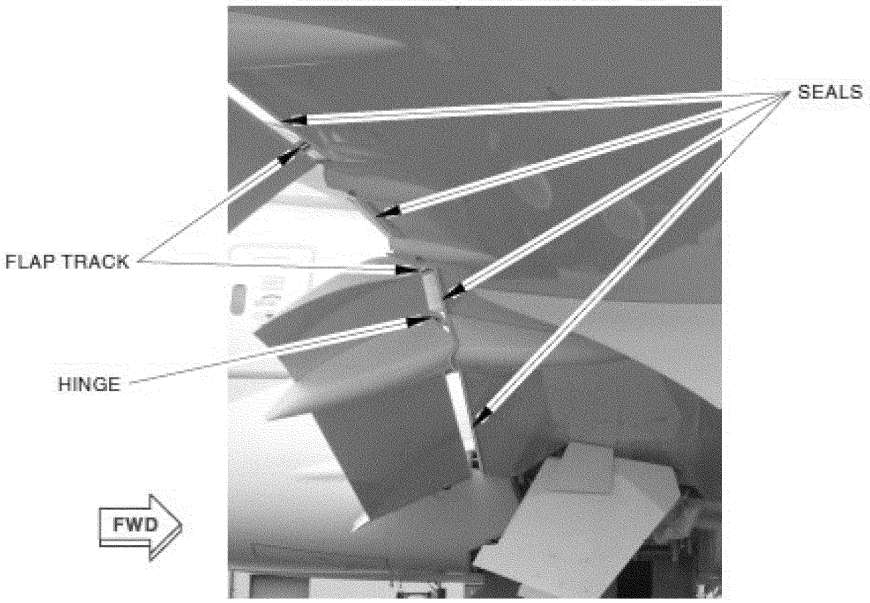
Figure 2 (Sheet 3 of 3) Slat and Flap Inspection

SLAT COVE
(TYPICAL)
A-A

FLAP TRACKS, HINGES, SEALS
(TYPICAL)
B-B
